Confidential Contract Report CR-2004/59

**First Level Analysis Report:  
HVS Testing of the Concrete  
Inlays on the N3 near Hilton:  
Test 424A5**

*Version: Final*

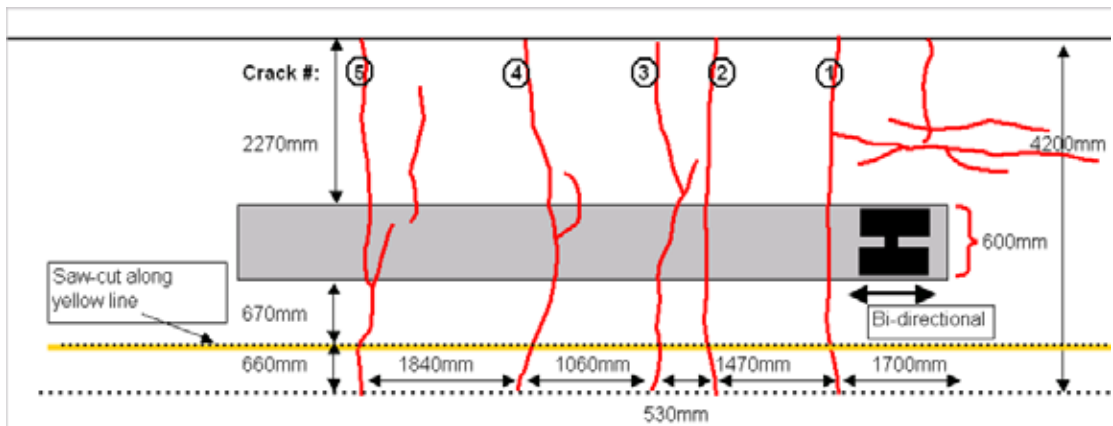
**Figure 2.1: Crack patterns of 424A5 prior to HVS testing**

The test section finally selected at km 16.3 had a significant amount of transverse cracking prior to HVS testing. Five transverse cracks were found in the 8m long test area. (See Picture 2.3). As indicated above, this particular test section was selected on basis that the crack patterns should be representative of those in typical concrete inlays.

During the HVS testing the performance and behaviour of the 5 transverse cracks indicated in Figure 2.1 were investigated.

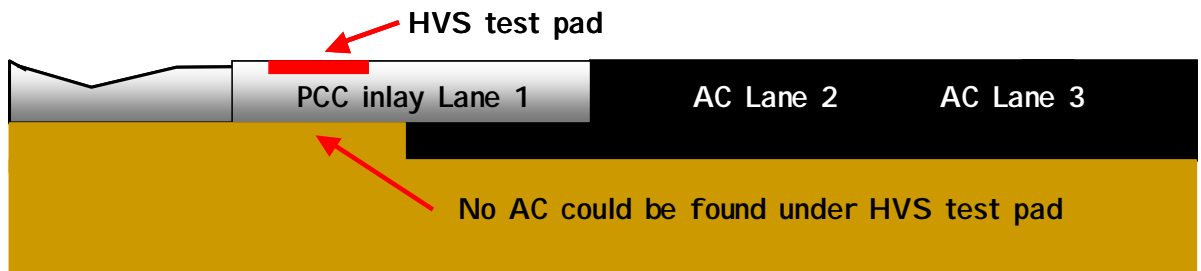
**Figure 5.9: Possible pavement structure at km 16.3**

While the holes were being cored at the HVS site it was discovered that there was no asphalt under the areas where the MDD holes were drilled. One possible explanation for not finding any asphalt under the concrete inlay might be that, because of width restrictions, the contractor could not fit 3 lanes together with the concrete shoulder and catch water drain in the available space and the PCC inlay was constructed partially inside the shoulder as indicated in Figure 5.9

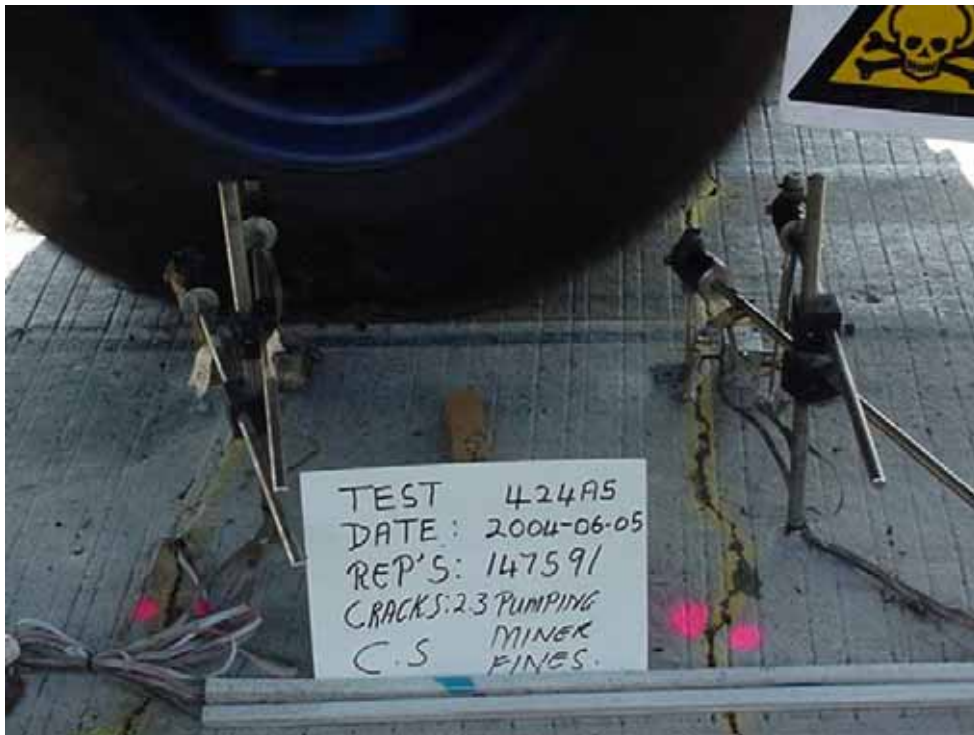
**Picture 5.1: Minor degree of pumping after water has been added**

A minor degree of pumping of fines was observed at all cracks after the addition of 444 litres of water and 15 700 repetitions. At that time a total of 147 591 repetitions had been applied to the section. (See Picture 5.1).

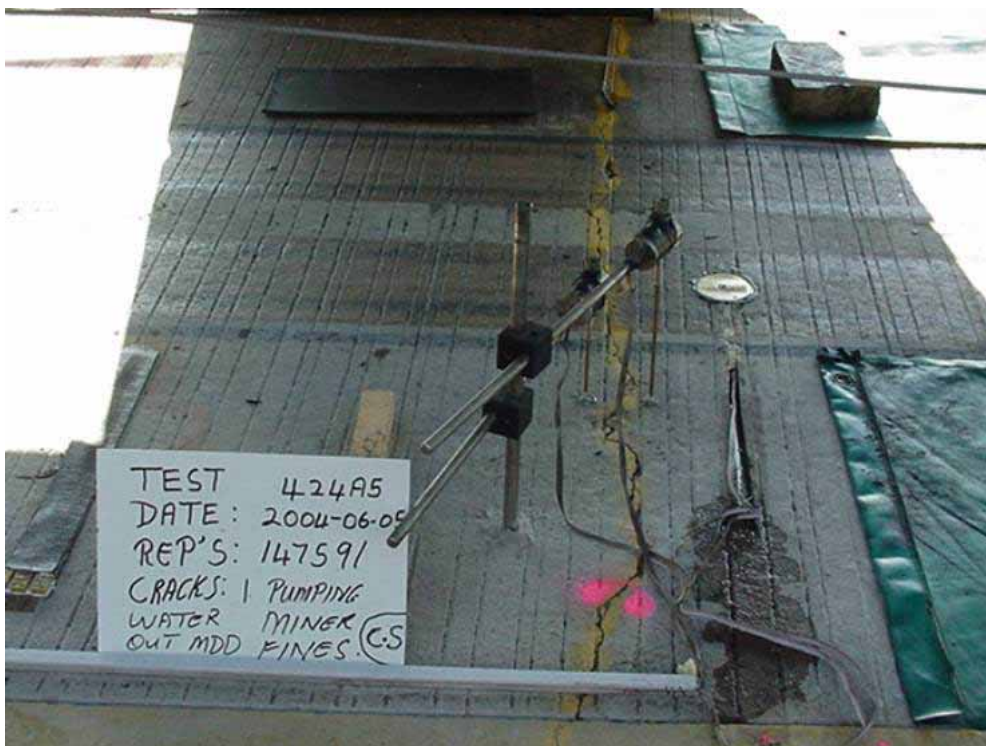
**Picture 5.2: Water seeping out of the MDD holes**

Clean water (no fines) also came out of the MDD holes (Picture 5.2)

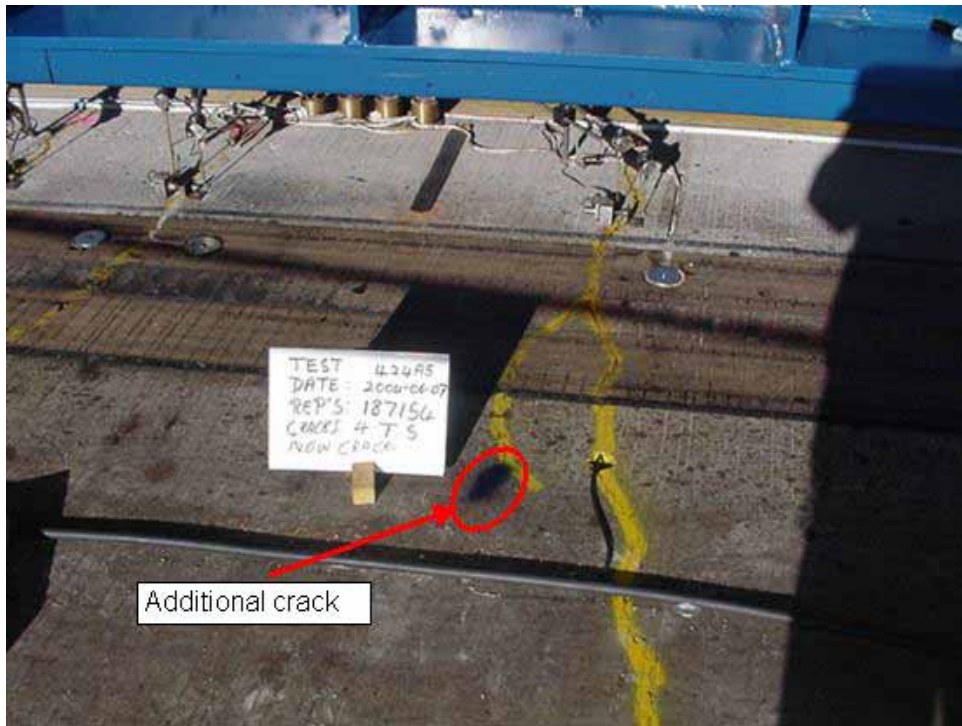
Two small additional cracks were observed at cracks 4 and 5 on 7 June after 187 154 repetitions. These new cracks were however very small and their widths could not be measured (see Pictures 5.3 and 5.4).

Picture 5.3: Additional hairline crack at crack # 4

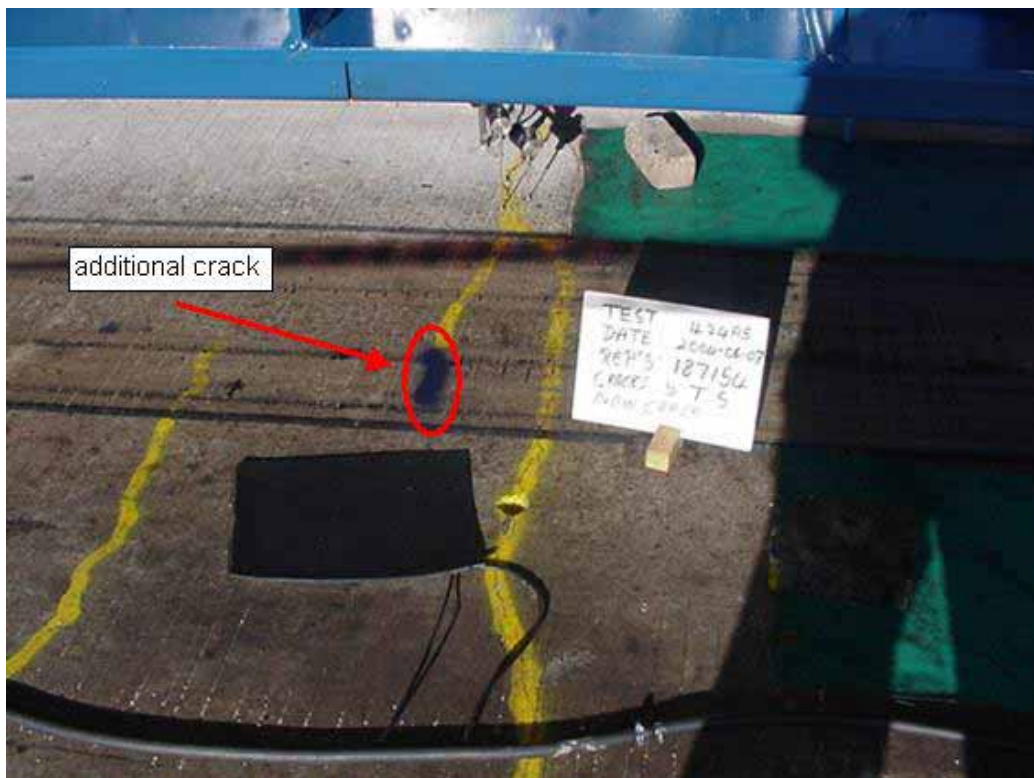
Picture 5.4: Additional hairline crack at Crack 5

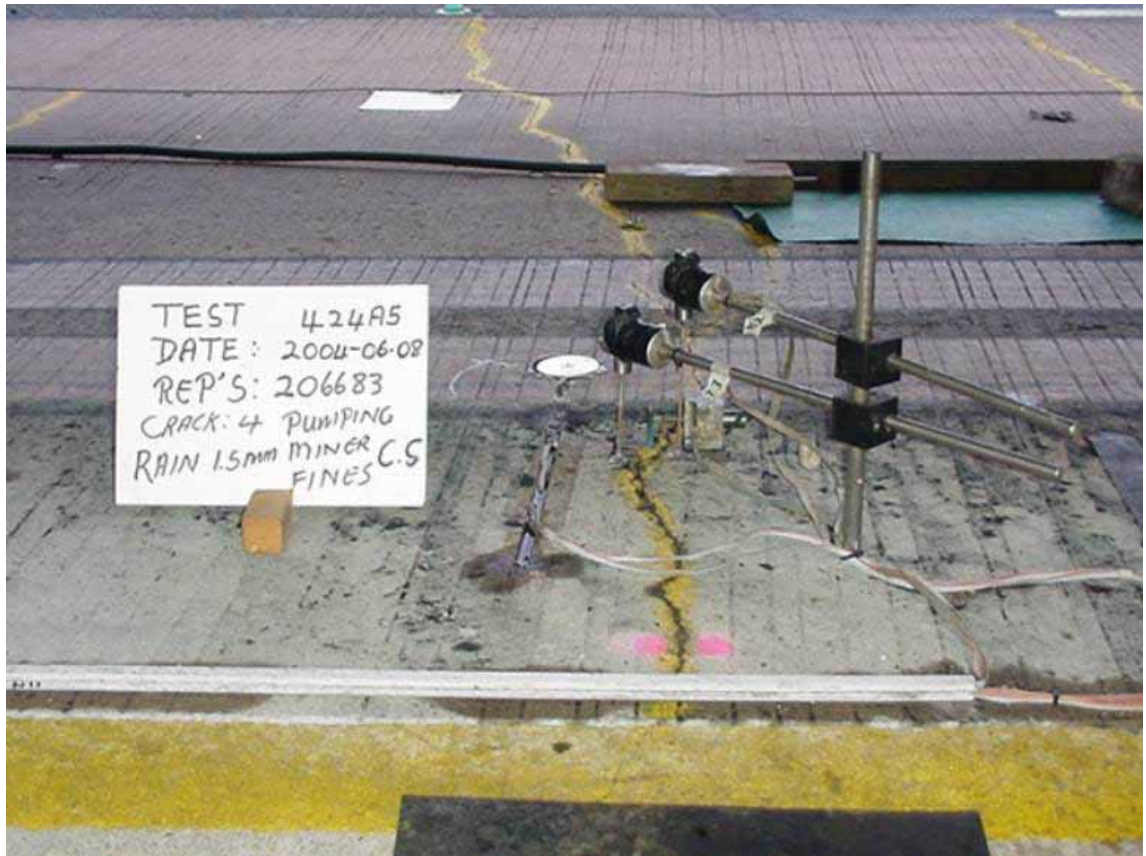
On 8 June (after 206 683 repetitions) 1,5mm of rain fell, which caused some additional pumping, but no significant changes were observed. See Picture 5.5.

**Picture 5.5: Pumping of fines after 206 683 repetitions**

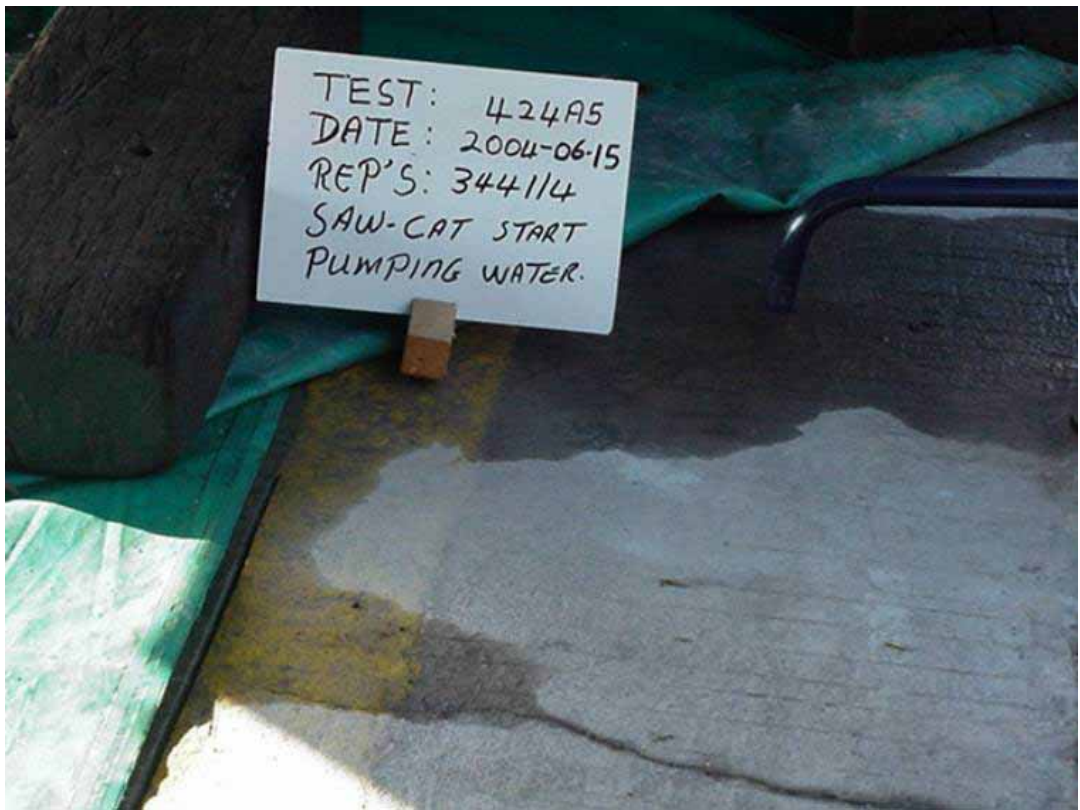
The addition of water, including the rain did not have any visible effect on the rate of deterioration and after 344 114 repetitions it was decided to increase the trafficking load from 60 to 80 kN. At this time water also started to come out of the longitudinal saw-cut joints along the yellow line (Picture 5.6).

**Picture 5.6: Clean water pumping out of longitudinal saw-cut edge after 344 114 repetitions**

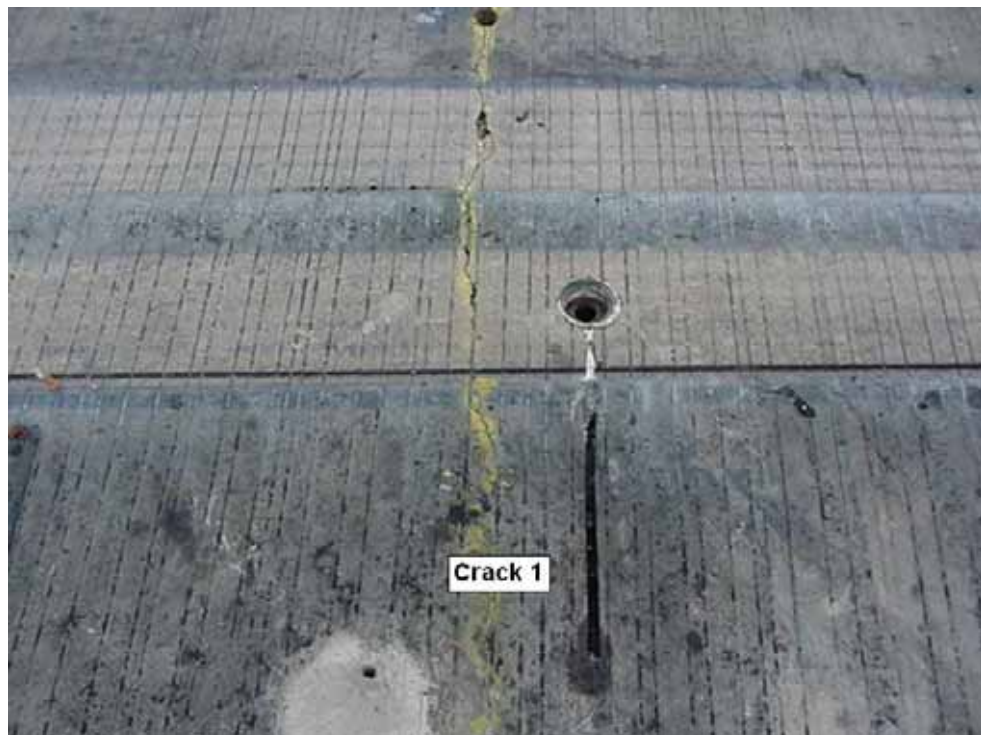
**Picture 5.7: Final condition of Crack 1**

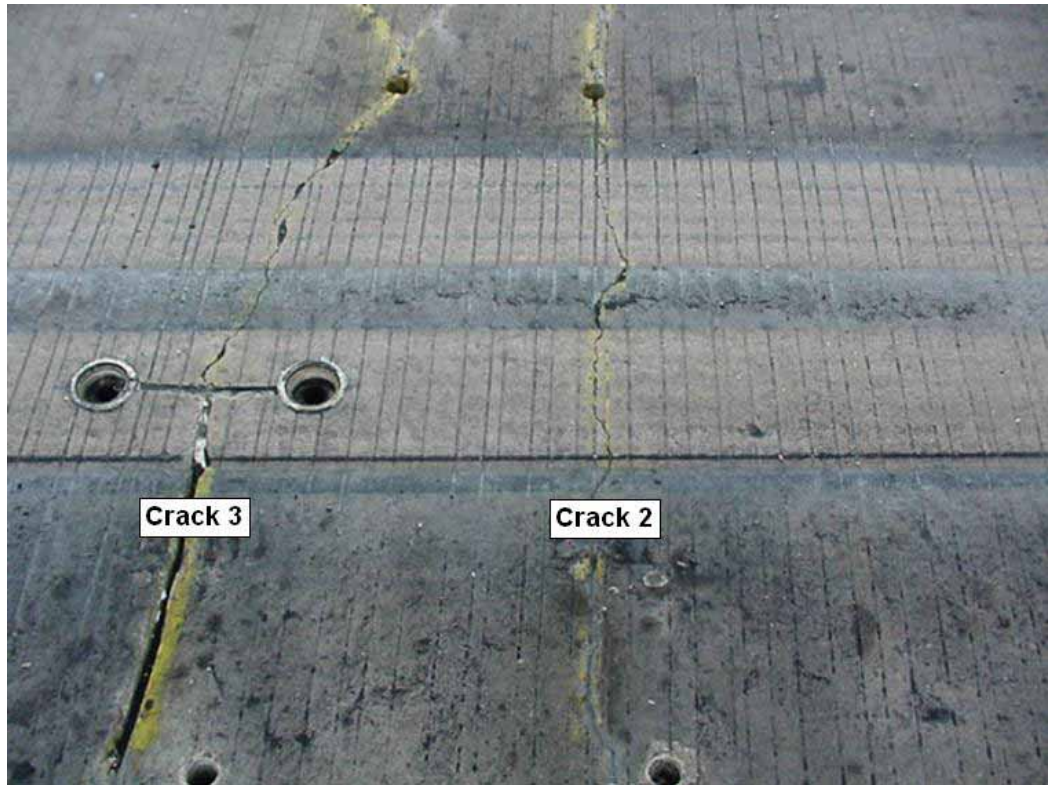
**Picture 5.8: Final condition of Cracks 2 and 3**

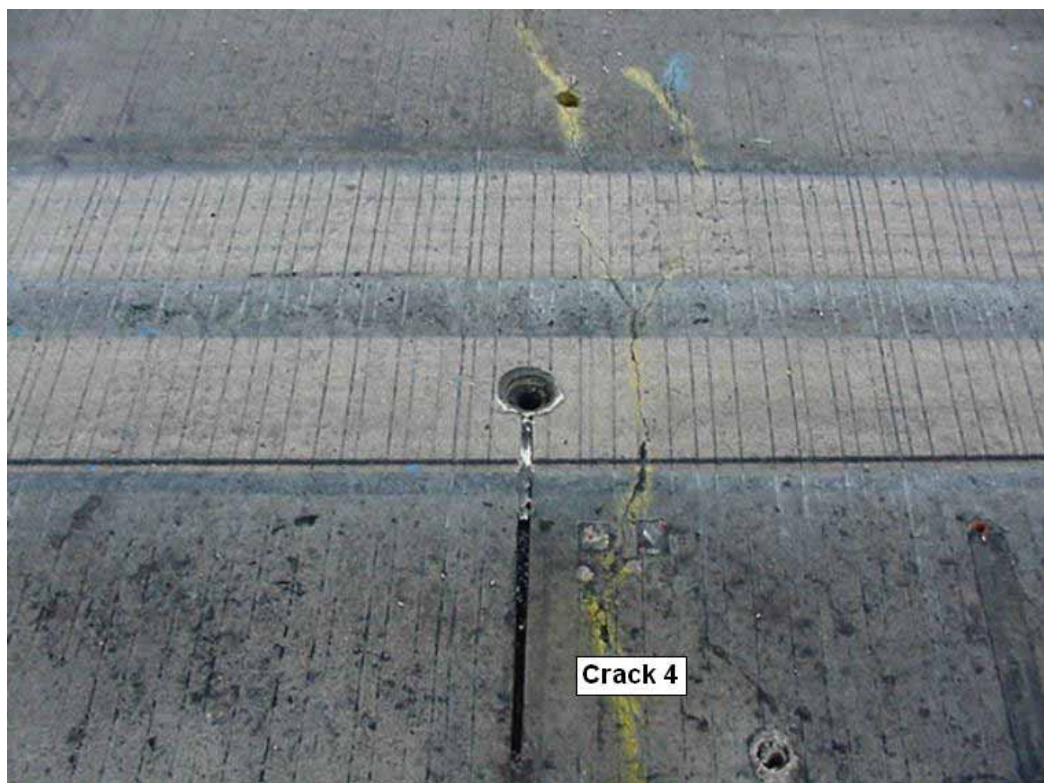
**Picture 5.9: Final condition of Crack 4**

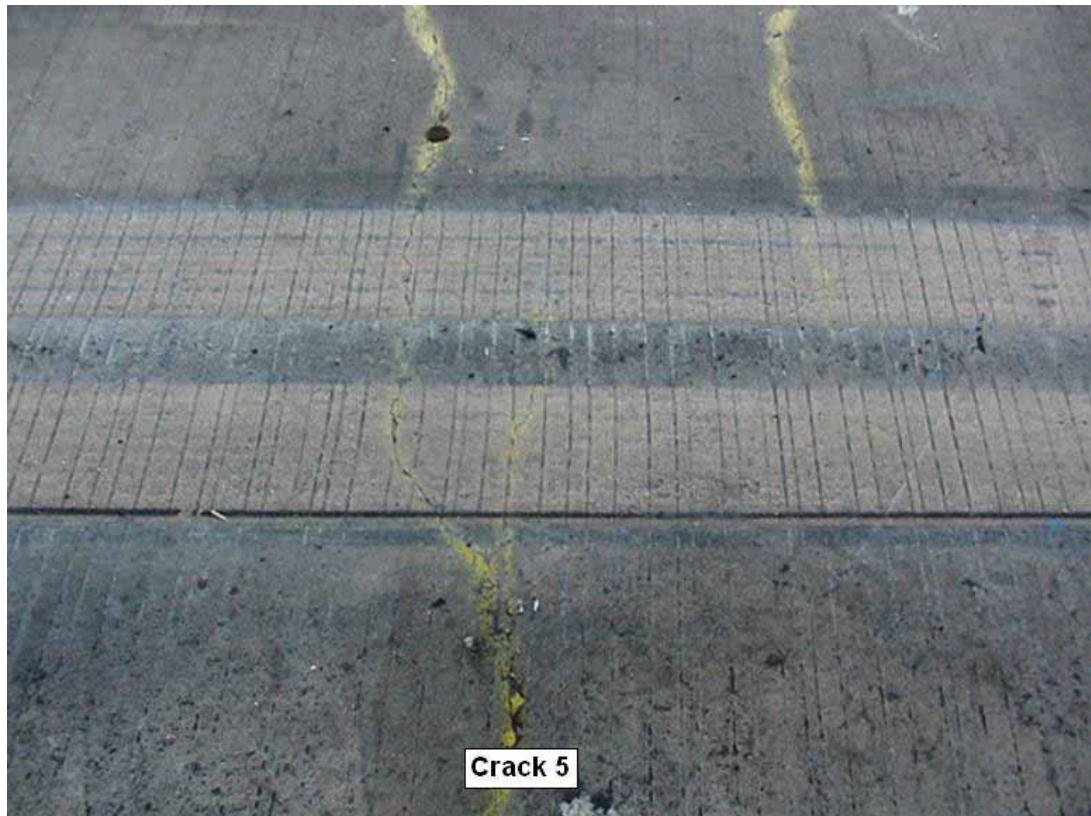
**Picture 5.10: Final condition of Crack 5**

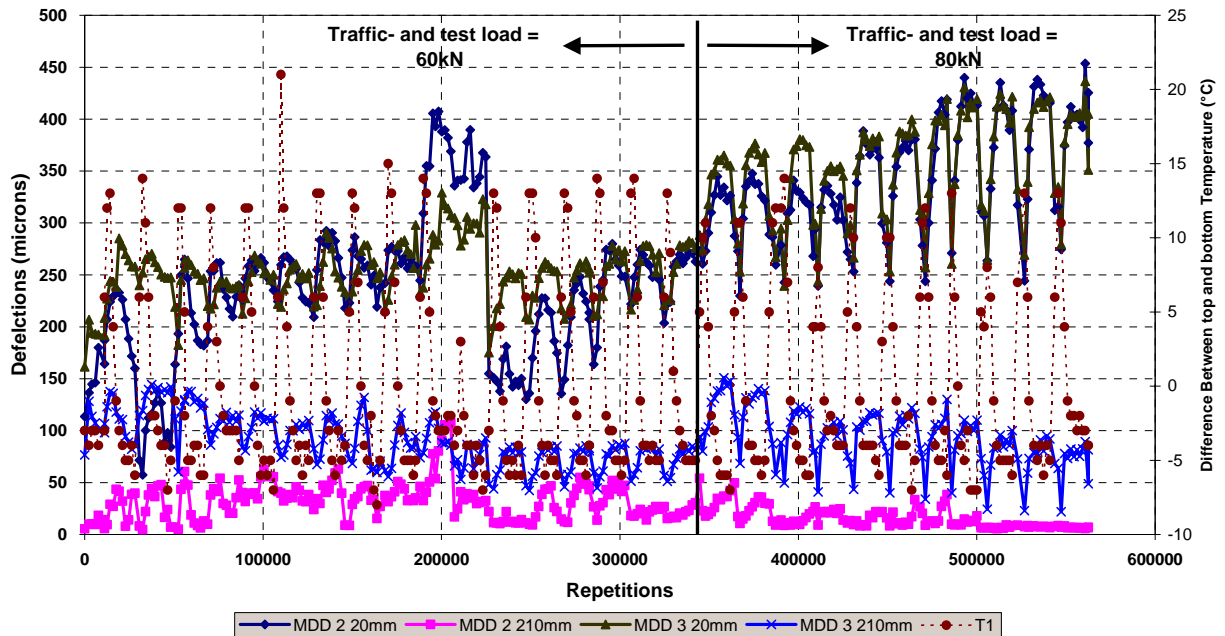
**Figure 5.22 Deflection data MDDs 2 and 3**

It is clear that MDD 2 at 20mm recorded erroneous results during the first 220 000 repetitions. The reason for this is not known and this data set should be excluded from any analysis.
