**Technical Memorandum:  
Second and third monitoring  
of three LTPP experiments in  
association with HVS tests in  
Gauteng**

<b>DOCUMENT RETRIEVAL PAGE</b>			<b>Report No:</b> <b>CSIR/BE/IE/ER/2006/0017/B</b>	
<b>Title:</b> Technical Memorandum: Second and third monitoring of three LTPP experiments in association with HVS tests in Gauteng				
<b>Author:</b> D Jones				
<b>Client:</b> GDPTRW		<b>Client Reference No:</b>	<b>Date:</b> March 2006	<b>Distribution:</b> Client Confidential
<b>Project No:</b> 59E2004		<b>RG:</b> 059E2 - Transport Infrastructure Engineering		<b>Version:</b> 1
<p><b>Abstract:</b></p> <p>This report summarizes the ongoing seasonal monitoring of three LTPP sections located adjacent to previous HVS experiments. The sections were assessed in July and November 2005. No further deterioration was noted on any of the three sections during the two evaluations detailed in this report. Some potential seasonal variation in terms of moisture content, and its influence on density and deflection, seems to be apparent, although additional monitoring will be required before any firm conclusions can be drawn. DCP measurements continue to be influenced by the stony nature

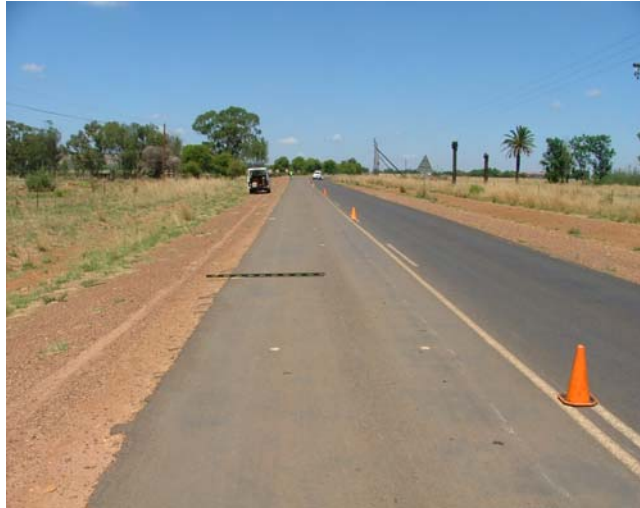
There was no further deterioration on this section. However, the surface was less tacky during the July 2005 assessment as a result of lower ambient and pavement temperatures (19°C and 17°C respectively). During the November 2005 assessment (32 °C and >40°C air and pavement temperatures), shoe and tyre impressions were again left in the road. The flushed binder also adhered to shoes and the pavement monitoring equipment during the November 2005 assessment, similar to that experienced during the February 2005 assessment.

**Figure 3.2: General view of H1-04-G-2388**

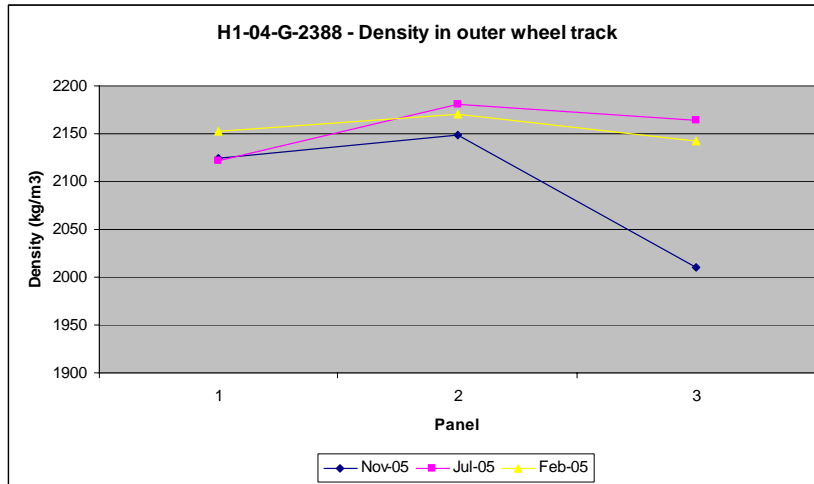
Density measurements remained relatively constant (see Figure 3.3 for example of outer wheel track measurements), although some spurious readings were obtained. These were attributed to crumbling of the material in the hole. Moisture contents also remained relatively constant (example in Figure 3.4) with a slight increase in the July 2005 measurements, attributed to the end of the rain season.

Figure 3.3: Density in outer wheel path on Section H1-04-G-2388

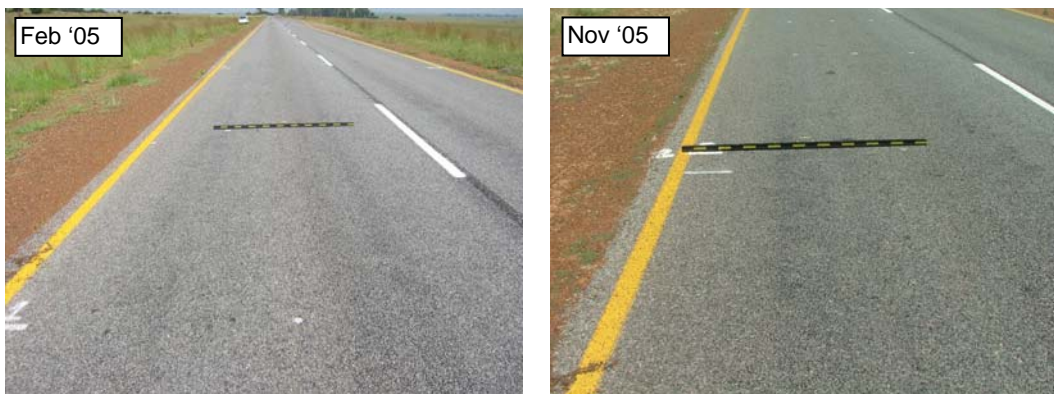
There was no further deterioration on this section. Bleeding was the only form of surfacing distress noted (rated as severity 1), however, the severity and extent had not changed since the previous visit (Figure 4.1).

**Figure 5.1: Slight bleeding in wheel paths on H3-04-G-243, Feb and Nov'05**

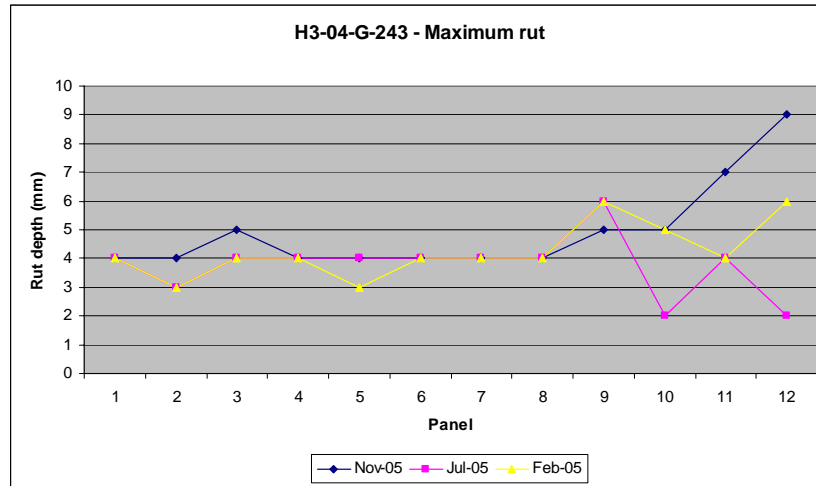
Rut depth had not increased (Figure 5.2) - discrepancies were attributed to change in assessors. No undulation, potholes or patching were recorded. No edgebreak was recorded, and the damage to the surfacing caused by the encroachment of grass was observed along the section had not deteriorated.

**Figure 5.2: Maximum rut for Section H3-04-G-243**

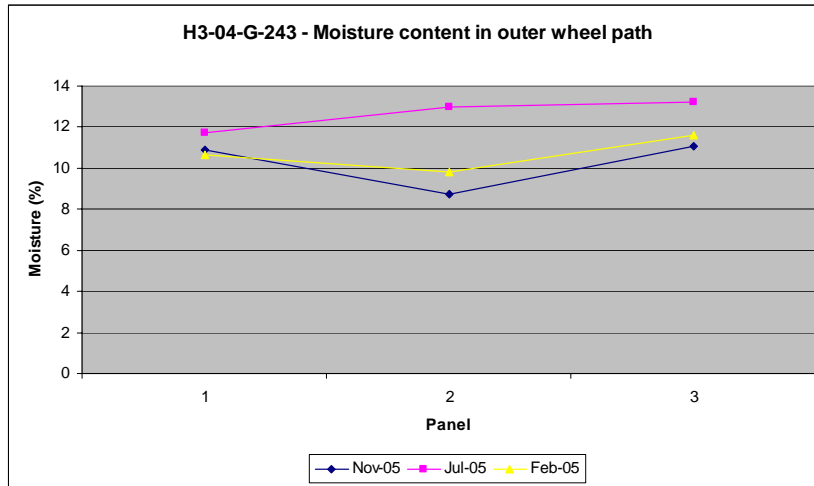
The density and moisture measurements recorded in November 2005 were almost identical to those recorded in February (see Figures 5.3 and 5.4 for example of outer wheel track measurements). However, the density and moisture measurements in July 2005 were lower and higher respectively. It is unclear whether this is as a result of inconsistencies in the measurement and further seasonal measurements will be required before trends can be better understood.

**Figure 5.4: Moisture in outer wheel path on Section H3-04-G-243**
