Contract Report

**Project Summary: HVS  
testing of N12-19 East  
Section 2.**

## **2. ANALYSIS OF THE PERFORMANCE OF A LONG LIFE PAVEMENT IN SOUTH AFRICA – N12 EXPERIMENTAL SECTION 2**

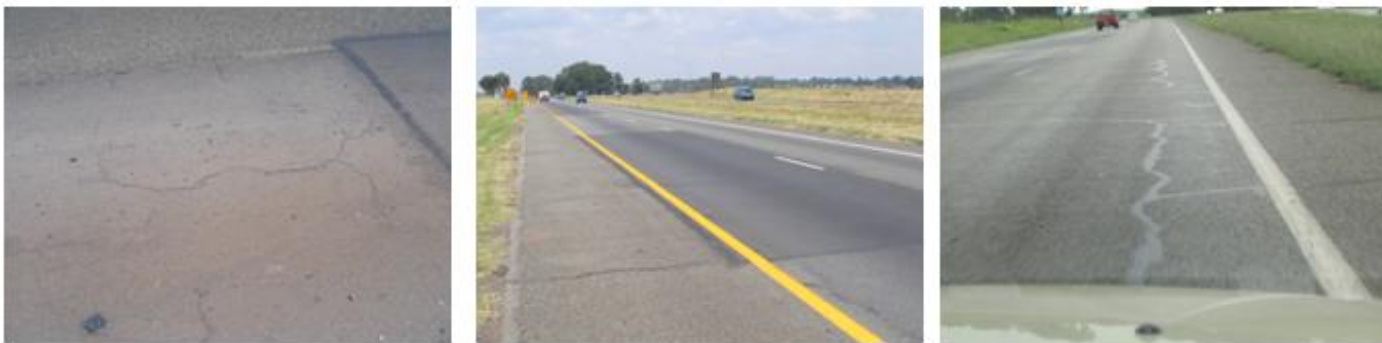
**Selected images of road N12 outside Section 2**

**Selected images of road N12 inside Section 2**

**Figure 5 Comparison between portions outside Section 2 and Section 2.**

Based on this definition, the N12 Section 2 discussed in this paper is seen as a success story. This is based on the evaluation of the initial design of the road, the performance of similar roads in the vicinity (refer to Figure 5) and the lack of maintenance actions on the road during its life. The most significant findings from the HVS and laboratory tests conducted and discussed in this paper are:
