# HVS FOCUS

APRIL 2005

## HVS TESTING ON N12

# HVS TESTING OF CONCRETE PAVEMENT STRUCTURES IN KWAZULU-NATAL

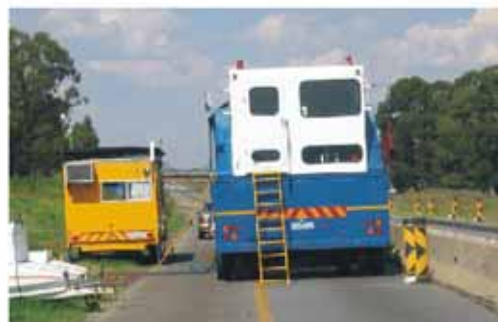
HVS testing on N12 ▲

The Gautrans HVS has been used to test a 30-year old Emulsion Treated Base (ETB) section on the N12-19 East of Johannesburg since January 2005. This section is one of 8 that form part of the original S12 experiment that was conducted in the early 1970s to compare various subbase, base and surfacing designs. The objective of the current tests is to determine the ultimate strength and failure mechanisms of the rehabilitated ETB section. This section was rehabilitated in 1974 after the initial CTB section failed prematurely. The CTB was ripped and 1 per cent emulsion was added to the material before being compacted and surfaced with 50 mm of asphalt and a 13 mm rubber seal. Since construction, the only maintenance has been a fog spray applied in 1992.

The test was initiated using a nominal 40 kN/690 kPa dual wheel load, which was increased to 80 kN/800 kPa after 20 000 load applications. For the last 850 000 load applications a load of 100 kN/800 kPa has been used.

The current data from the experiment indicate that the road structure is still in a very good condition, even after the application of an additional 10 to 20 years of heavy vehicle traffic. The road surfacing has remained intact, preventing the ingress of water.

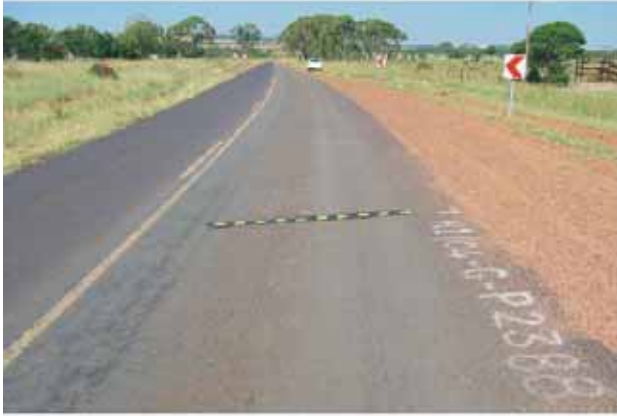
Taking RSD measurements at Cullinan

- a visual assessment;
- transverse and longitudinal profile;
- DCP;
- in situ density and moisture content;
- riding quality measurements, and
- deflection measurements (Falling Weight Deflectometer (FWD) and Road Surface Deflectometer (RSD)).

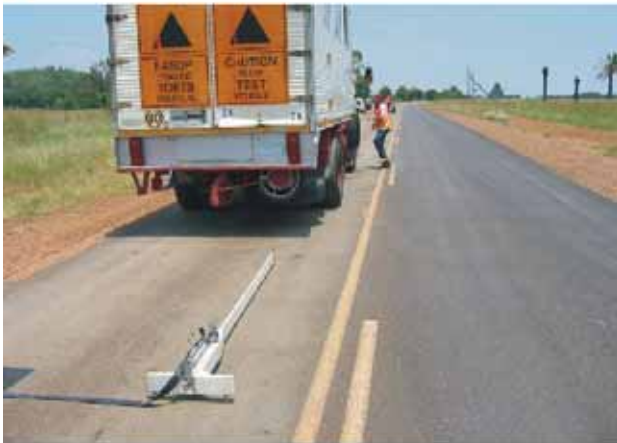
A typical LTPP section layout

To date, three LTPP sections have been established, two adjacent to the HVS sections constructed near Cullinan on Road D2388 (labour intensive constructed emulsion treated gravel) and one adjacent to the HVS sections on Road P243/1 between Vereeniging and Heidelberg (deep in situ recycling with foam bitumen). It is expected that the foam bitumen treatment on the N7 near Cape Town will also be included in the program. Each section is 200 m long and is divided into 10 x 15 m long evaluation panels and 3 panels reserved for destructive testing (ends and middle).

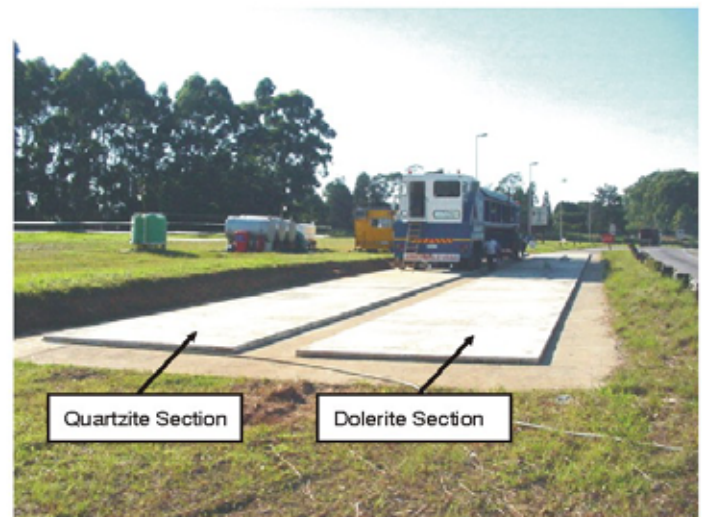
▲ HVS test sections at Hilton

To address especially the load transfer issue, two HVS experimental Portland cement concrete (PCC) sections were constructed at the Hilton off ramp, close to Pietermaritzburg on the N3. These sections were subjected to accelerated loading for a period of over 7 months starting November 2003.

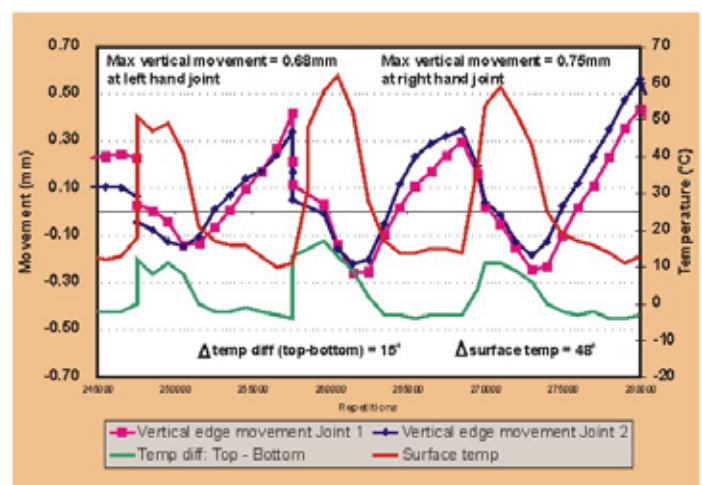
▲ Typical correlation between temperature and slab curl

Temperature changes have a significant effect on slab edge and corner curl. Slab curl due to differential temperatures between the top and the bottom of the slabs were monitored every 2 hours together with ambient temperature, and the temperatures at the top and bottom of the slabs. Slab curl as high as 0.75 mm was recorded on the doweled quartzite

sections under the influence of a maximum temperature differential of 15°C and a maximum surface temperature of 48°C.

This effect highlights the importance of proper concrete pavement design. At night the edges of the concrete slabs curl upwards due to the negative temperature differential between the surface and the bottom. This curling effect creates a cavity under the slab and the loss of support from the pavement structure under the concrete will have a negative effect on the long-term performance of the pavement, especially when heavy vehicles travel close to the shoulder of the road at night.

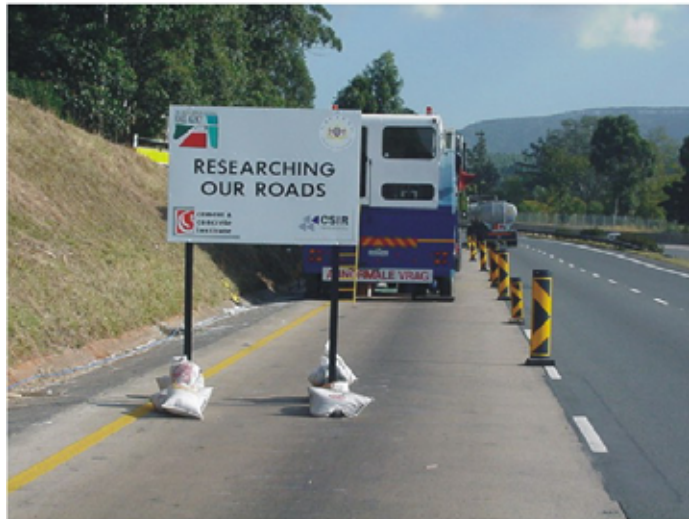
◀ HVS testing on the N3 PCC inlay

The section was subjected to 340 000 60 kN load applications followed by 223 000 80 kN load applications. Due to the slow rate of any physical deterioration, water was introduced in all cracks from 130 000 repetitions onwards at a rate of approximately 22 litres per hour. Even with the aggressive loading and the introduction of water very little additional damage was detected.

The selected area was representative of the condition of a particular section of the N3 near Pietermaritzburg. The inlay consists of 180 mm continuously reinforced concrete (CRCP) placed on top of 150 mm of asphalt and 250 mm of stabilised dolerite crushed rock.

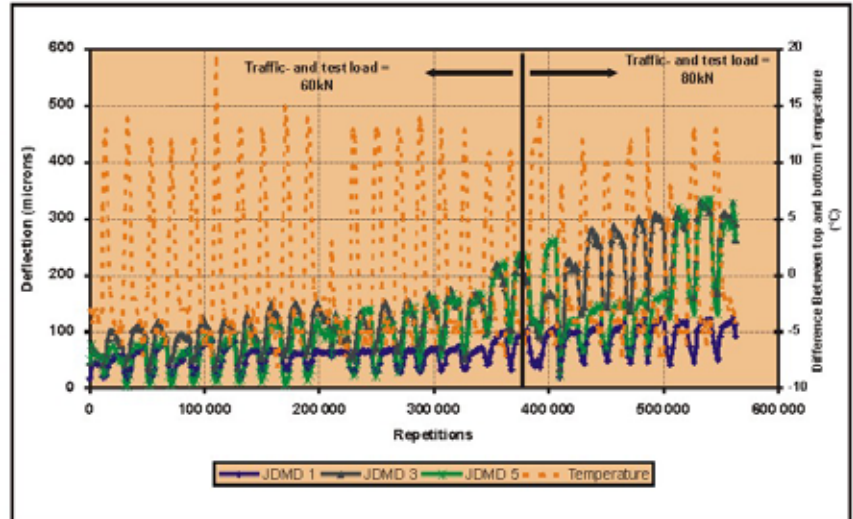
▲ Elastic deflections measured on cracks at the inlay HVS section

Deflection sensors (JDMDs) placed along the edge of the testing area reported deflections in the order of 0.2 mm at the end of the test. The relative movement across all cracks was also measured at 2 hour intervals. Relative movements of less than 0.15mm were recorded, even after the application of the aggressive 80kN load.

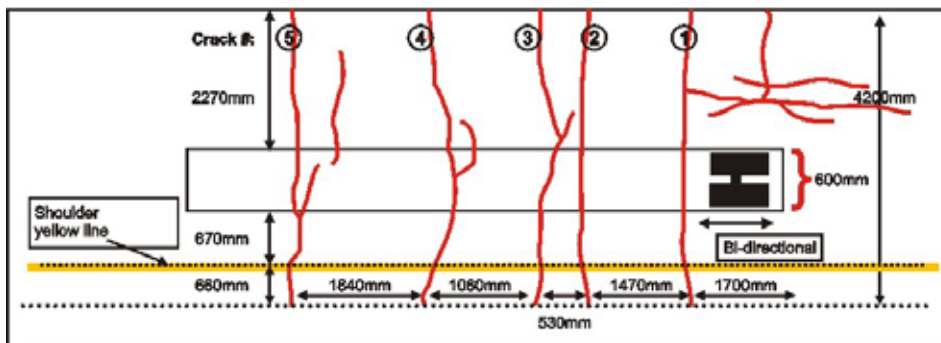
◀ Crack pattern at the inlay HVS test section

The pavement, constructed in 1998, had carried approximately 6.5 million standard axle loads. Due to the presence of a significant cracking pattern it became important to determine how long the structure would last before major rehabilitation would be required.
