Confidential Contract Report CR-2004/59

**First Level Analysis Report:  
HVS Testing of the Concrete  
Inlays on the N3 near Hilton:  
Test 424A5**

*Version: Final*

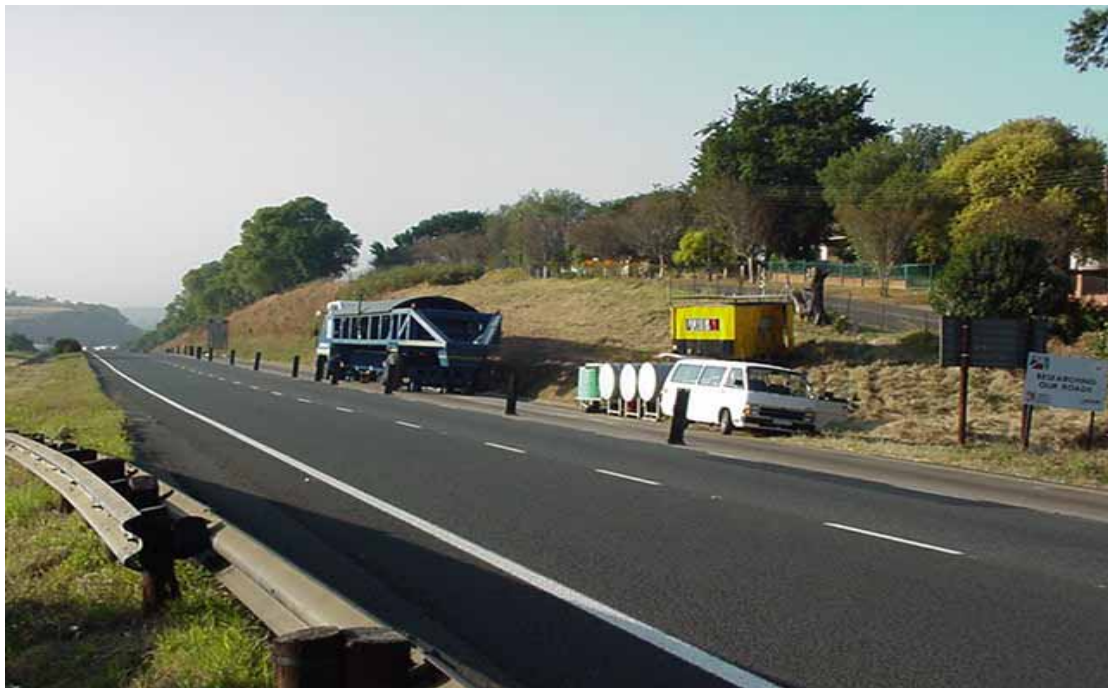
**Picture 2.1: Site selected for HVS testing at km 16.3 N3 north bound**

After several visual inspections along various inlay sections on the N3, an area at kilometre post 16.3 (northbound) was selected for HVS testing (see Pictures 2.1 and 2.2). The following important factors played a roll in the selection of an appropriate site:

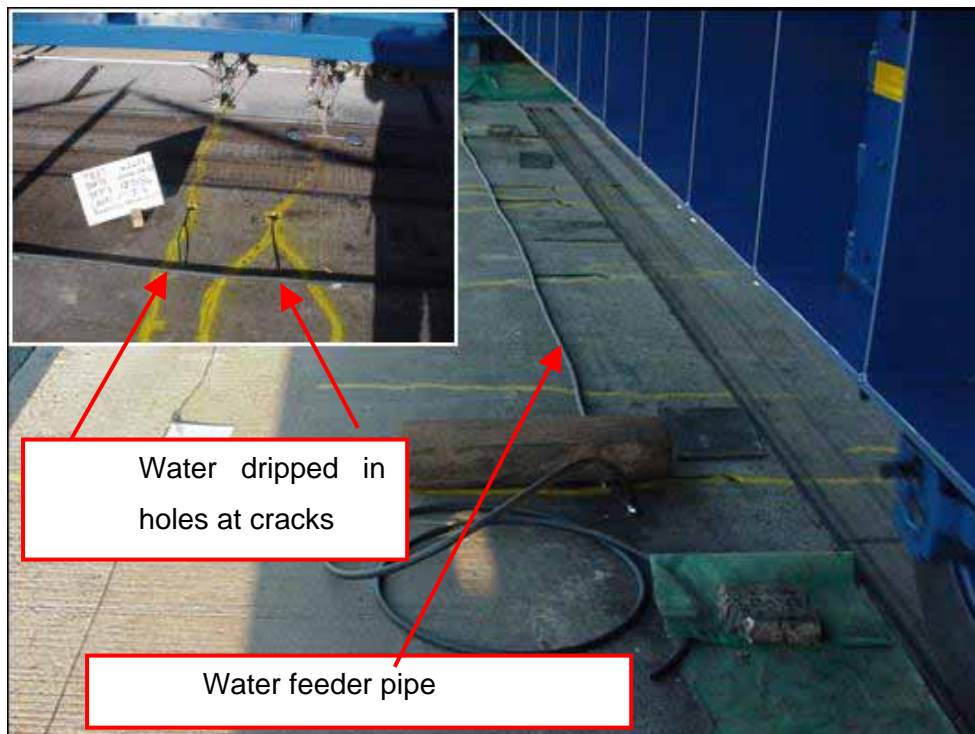
**Picture 3.1: Watering system used during testing**

Due to time constraints it was decided that if no dramatic change in pavement performance was observed after a week of testing (approximately 140 000 repetitions) water would be added to the cracks to speed up the deterioration process. Only four weeks of HVS testing was allowed for and it was felt that the addition of water might assist in deriving a useful result. Picture 3.1 shows the watering system. Water was introduced at the edge of the trafficking area through a dripping system at each crack. Water was added from the 4 June onwards after 131 873 load repetitions.

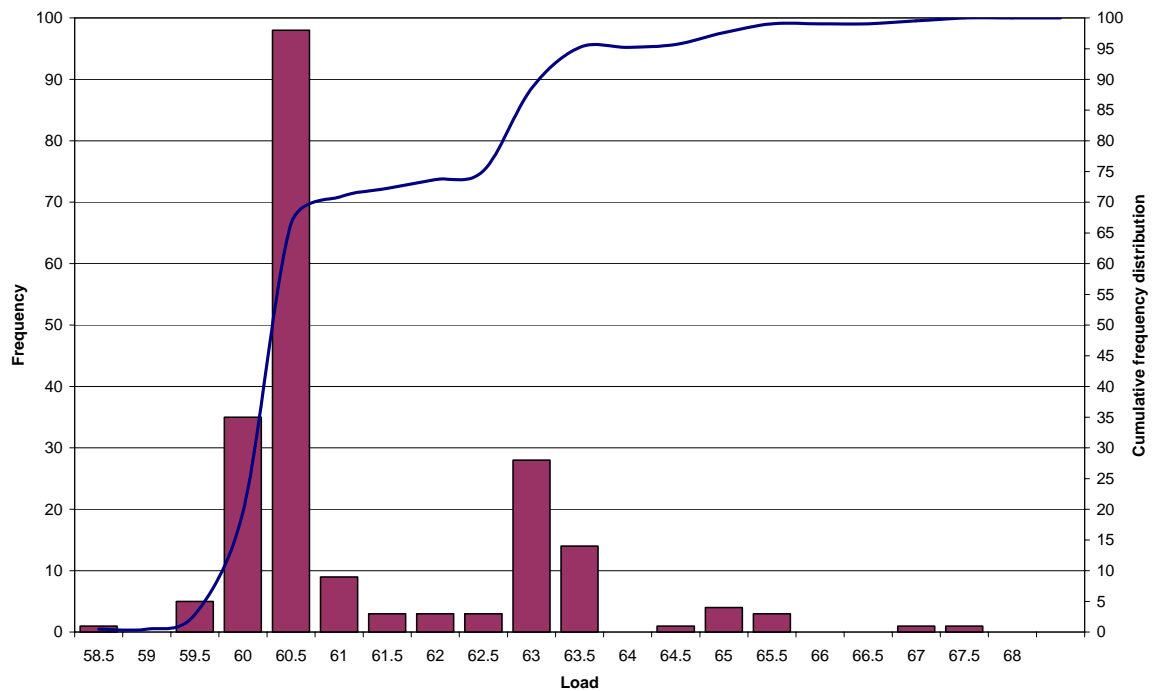
**Figure 3.1: 60kN loading histogram**

The 50<sup>th</sup> percentile value is 60.5 kN which is 0.5kN higher than the specified 60kN. The distribution is skewed to the right, indicating that for a greater percentage of time the load exceeded the required 60kN, rather than being lower.

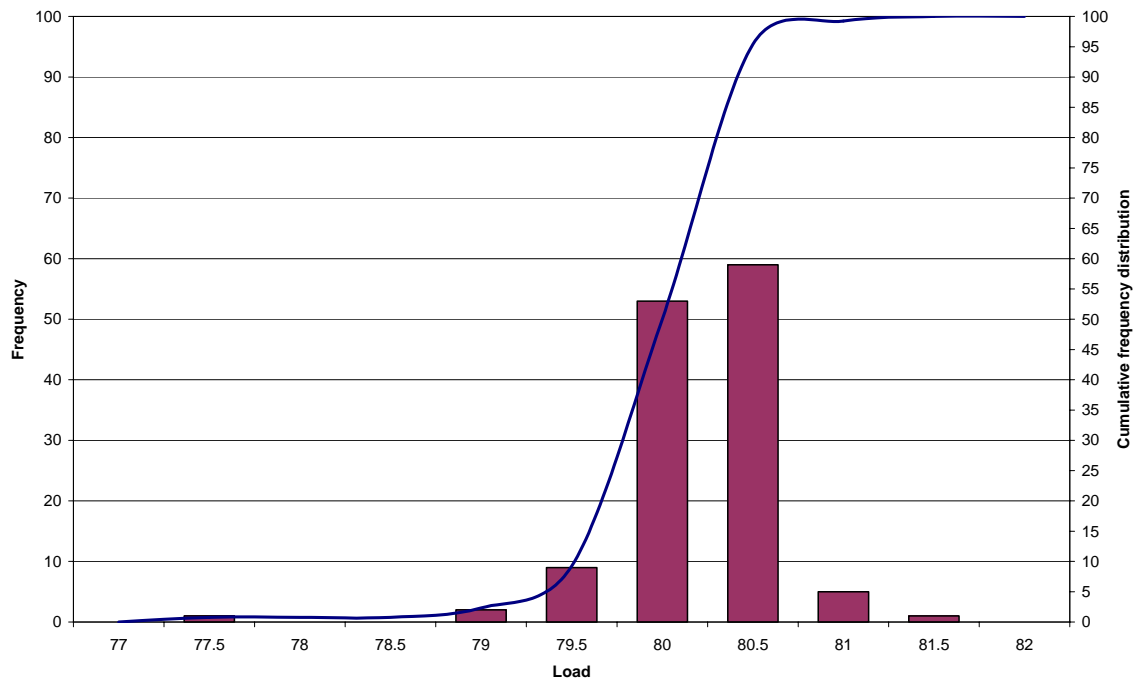
**Figure 3.2: 80kN loading histogram**

The loads applied during the 80kN phase were closer to the target load (see Figure 3.2). The total load variation was between 79 and 81.5 kN, the 50<sup>th</sup> percentile value being 80kN.

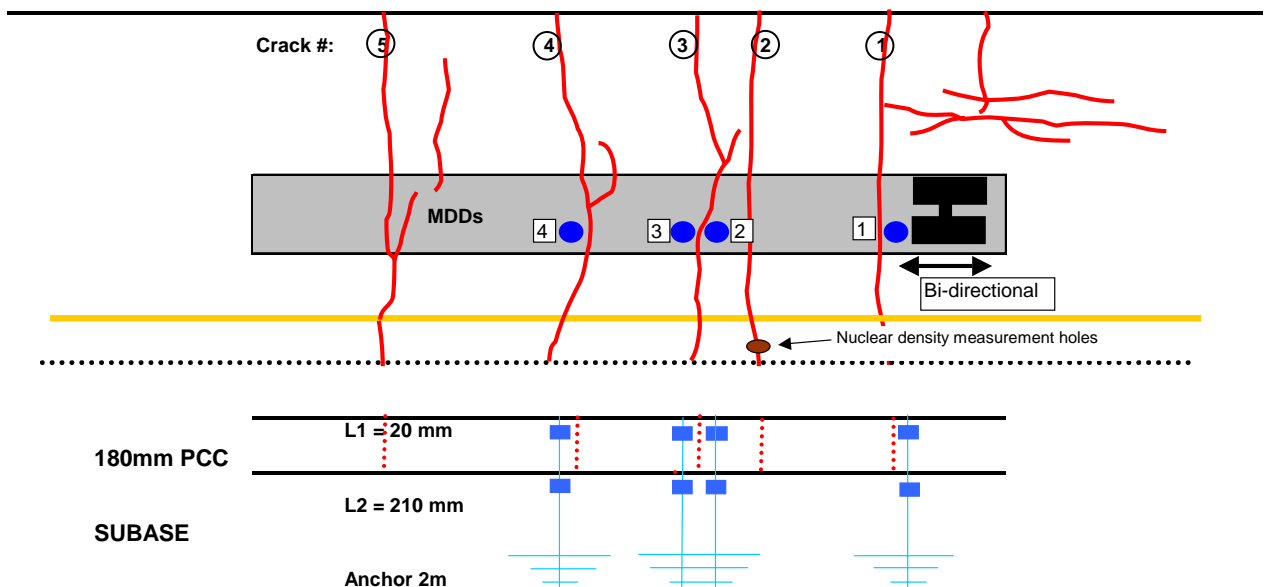
Figure 4.1: Placement of MDDs at test 424A5

- MDD 1 on the left side of Crack # 1
- MDDs 2 & 3: both sides of Crack # 3
- MDD 4: on the approach side of Crack # 5

MDD modules were placed inside the concrete at a depth of 20mm and in the subbase at a depth of 210mm. An illustration of the placement of the various MDDs can be seen in Figure 4.1.

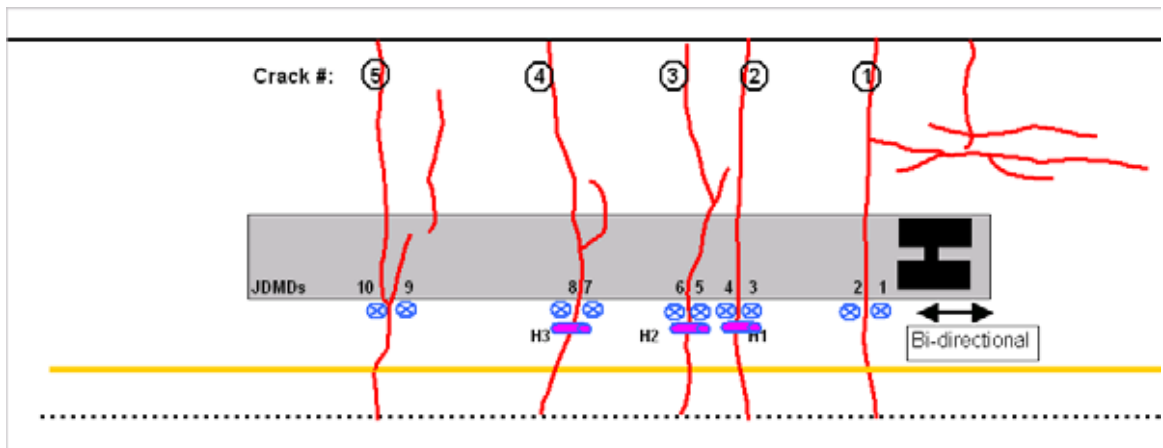
**Figure 4.2: Placement of JDMDs at test 424A5**

- JDMD 1 & 2: On both sides of Crack # 1
- JDMD 3 & 4 and Horizontal 1: on either side of, and across, Crack # 2
- JDMD 5 & 6 and Horizontal 2: on either side of, and across, Crack # 3
- JDMD 7 & 8 and Horizontal 3: on either side of, and across, Crack # 4
- JDMD 9 & 10: on both sides of Crack # 5.

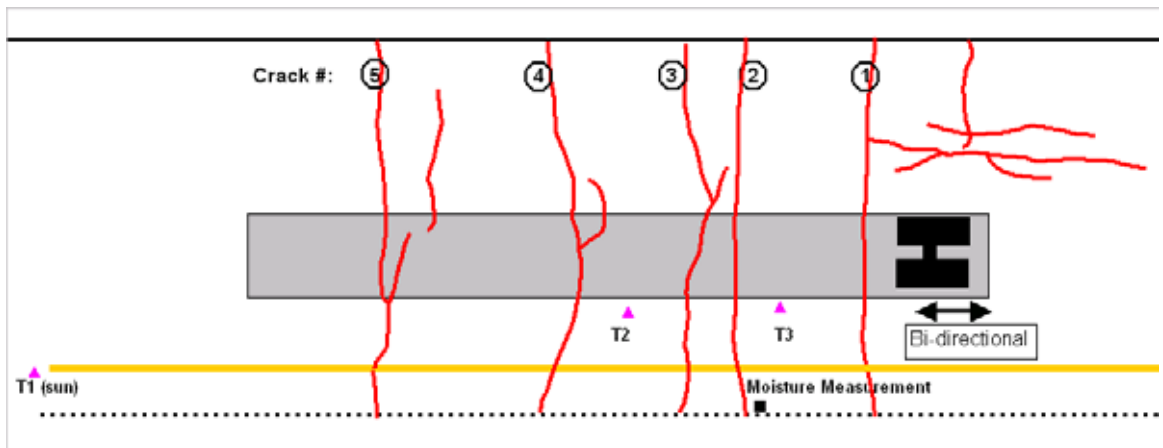
**Figure 4.3: Placement of thermocouples at test 424A5**

Thermocouples were installed to measure the temperature of the air, as well as of the surface and at various depths inside the concrete. Three thermocouples were installed for this test, two in close proximity to JDMDs 3,4 and 5,6 (T3 and T2 respectively) and one in the sun outside the influence area of the HVS and of its shade (T1).

Thermocouples were placed at the surface (0mm) at 90mm and at the bottom (180mm) of the PCC concrete layer. The placement of the various thermocouples is illustrated in Figure 4.3

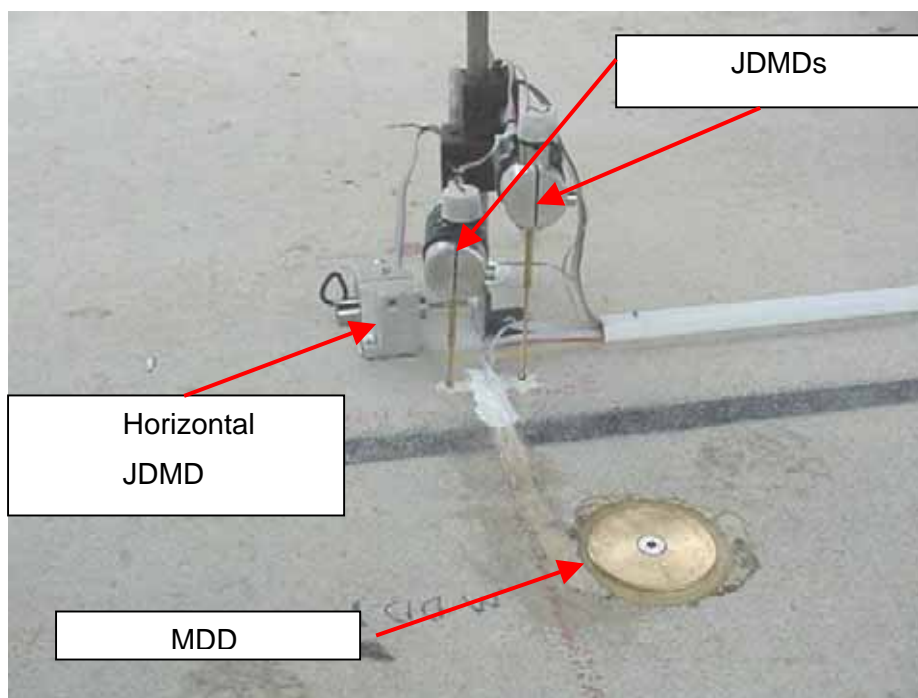
**Picture 4.1: JDMDs, MDD and horizontal JDMD used during testing**

Picture 4.1 shows the placement of JDMDs, one MDD as well as the horizontally placed JDMD that recorded the horizontal crack movements

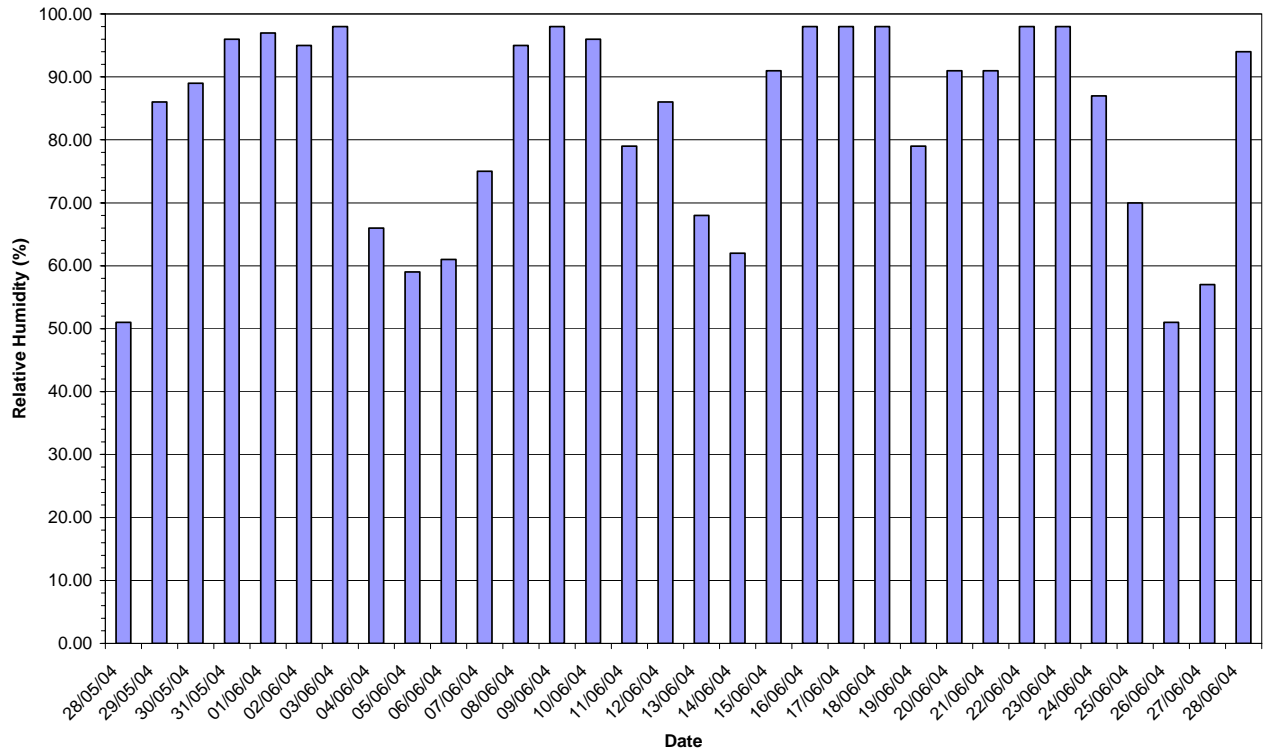
**Figure 5.1: Relative humidity during HVS testing**

The relative humidity data as recorded by the weather station at the HVS testing site can be seen in Figure 5.1. Data were collected 2-hour intervals. The graph shows the maximum relative humidity during any given 24-hour cycle within the testing period

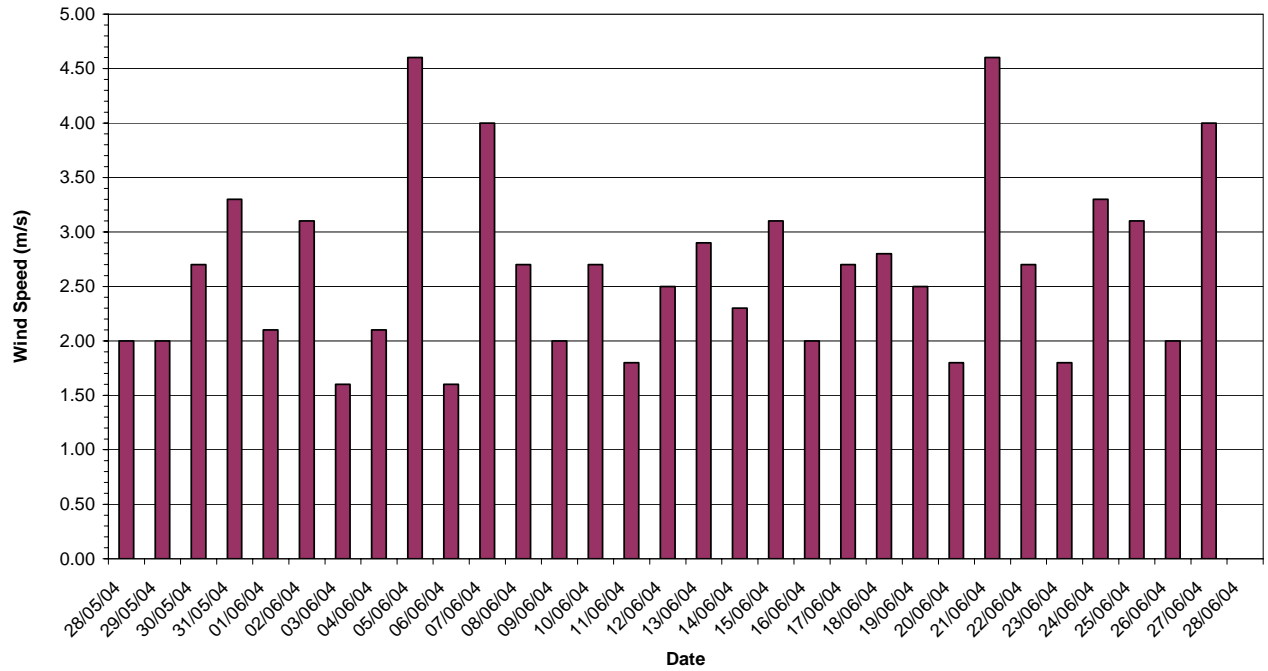
**Figure 5.2: Wind speeds recorded at the HVS site**

The wind speed as recorded by the weather station can be seen in Figure 5.2 for the duration of HVS testing. Like Figure 5.1, the data shown in Figure 5.2 represent the maximum wind speeds recorded within a 24-hour daily cycle.

If Figures 5.1 and 5.2 are compared it can be seen that periods with lower relative humidity correspond to periods of high wind speeds.

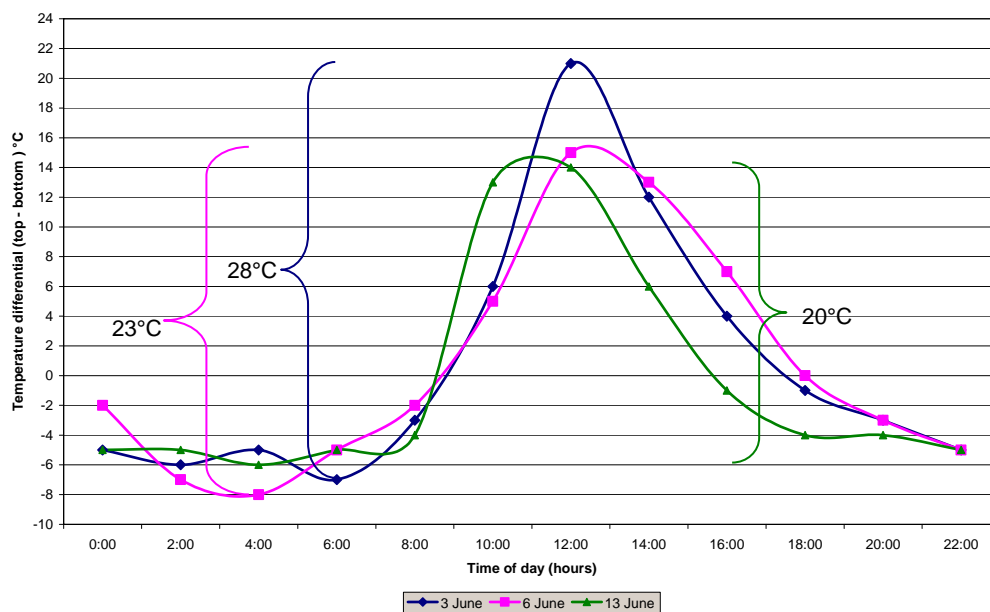
**Figure 5.6: Most significant temperature differentials in a 24-hour cycle**

The highest temperature differential between the top and the bottom of the PCC layer was observed on 3 June at 12:00. The difference was 21°C. The corresponding negative temperature differential was -7°C, which occurred at 6:00 in the morning. This means that the total temperature difference span during those 24 hours was 28°C as indicated in Figure 5.6.

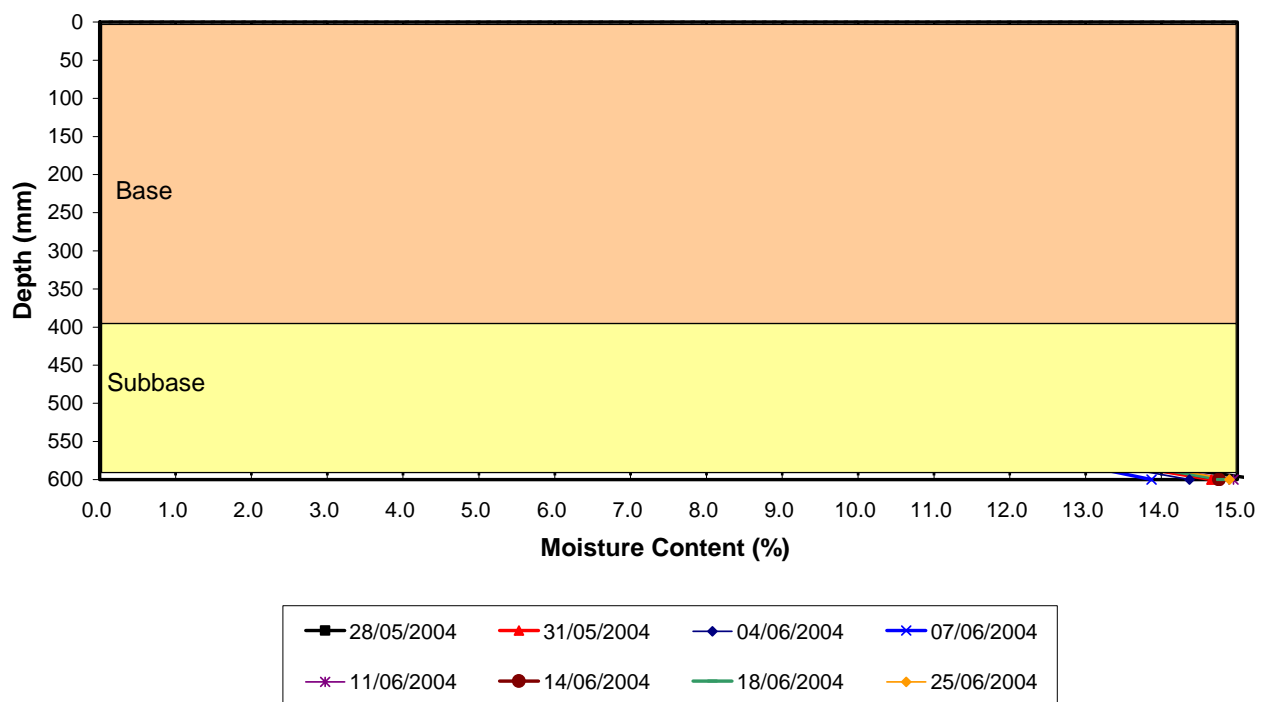
**Figure 5.7: Nuclear gauge density moisture content data at the HVS testing site**

In Figure 5.7 it can be seen that there was no significant variation in the moisture contents of the substructure during the testing period (28 May – 28 June). The moisture contents of the base layer varied between 3 and 6 per cent for the first 150mm, and increased to between 7 and 9.5 per cent, thereafter, peaking at a depth of 250mm. The

top 100mm of the subbase had a moisture content of between 8 and 9 per cent, which increased with depth to 15 per cent. The “S” shape of the moisture profile is consistent with other HVS tests done in the vicinity of Hilton. (1,2) . As no material sampling was done at the site to substantiate these moisture contents, the moisture contents measured by the nuclear gauge should be regarded as only an indication of the moisture profile.

The introduction of water to the cracks (4 June 2004) had a slight influence on the recorded moisture contents (compare the data set recorded on 31 May with the data sets after 4 June). It seems that the moisture contents at a depth of between 200 and 400mm increased by approximately 1 per cent after water had been introduced to the cracks. No significant increase could be seen in the moisture contents in the deeper part of the structure as a result of the influx of water from the top.

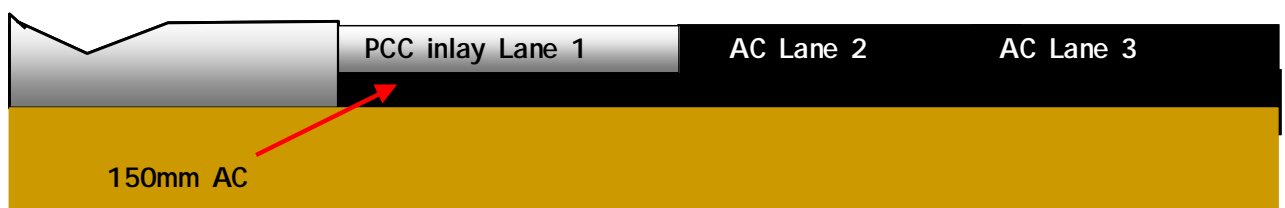
**Figure 5.8: Expected pavement structure at km 16.3**

According to design drawings of the inlays at the HVS testing site, the pavement structure should have been constructed with 180mm PCC on top of 150mm of asphalt placed on top of the granular layers (see Table 2.1). The left hand shoulder of the road consisted of a concrete shoulder with a catch water drain. This structure is schematically represented in Figure 5.8

While the holes were being cored at the HVS site it was discovered that there was no asphalt under the areas where the MDD holes were drilled. One possible explanation for not finding any asphalt under the concrete inlay might be that, because of width restrictions, the contractor could not fit 3 lanes together with the concrete shoulder and catch water drain in the available space and the PCC inlay was constructed partially inside the shoulder as indicated in Figure 5.9

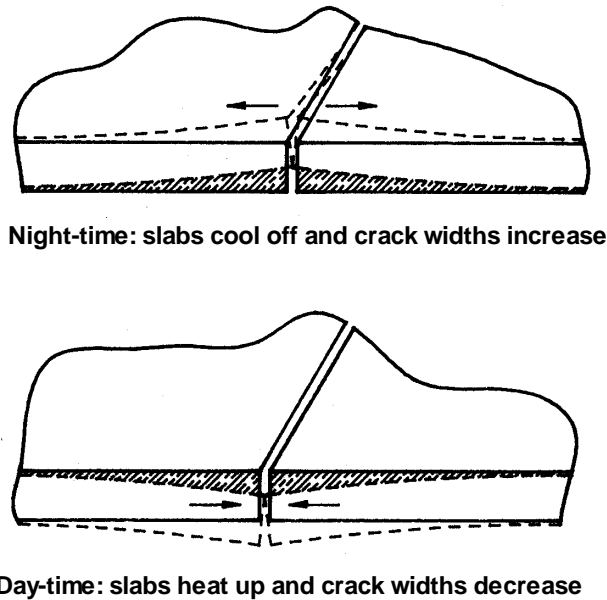
**Figure 5.11: Crack width changes with daily temperature variations**

Because of slab expansion / contraction caused by the rise and fall of the ambient temperature, crack widths fluctuate. During the night, the slabs cool down and the slabs contract, causing the cracks to widen. During the day, the opposite occurs: the slab heats up and expands and the crack widths decrease. The effect of this was measured by JDMDs placed horizontally (H1, H2 and H3) as detailed in Sec 4.1. This effect is illustrated in Figure 5.11.

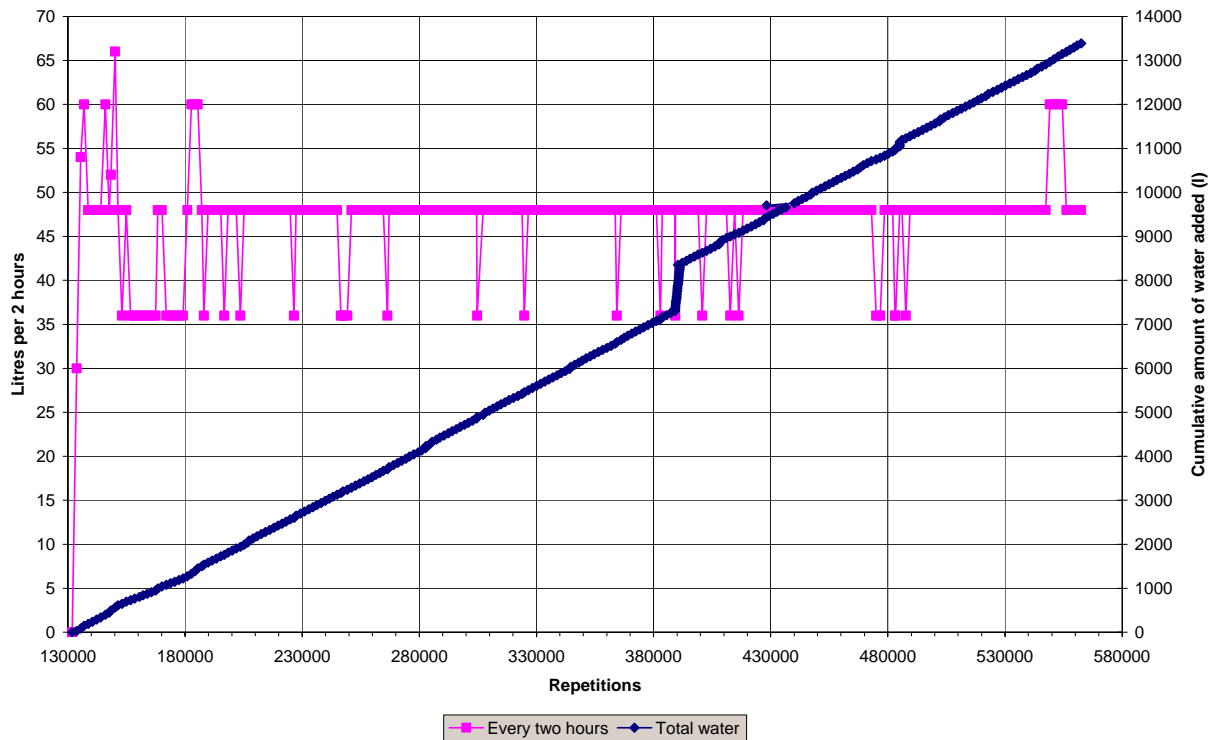
**Figure 5.12: Total amount of water added to the cracks**

at 2-hourly intervals and are presented in Figure 5.12. An average of approximately 47 litre of water was added every 2 hours or 564 litres per day. It seemed as if the water drained very rapidly under the pavement as only a small degree of pumping was observed throughout the testing period. The 2-hourly water consumption and the total amount of water added the sections can be seen in Figure 5.12.

A total of 1340 litres were added to the section during the 25 day watering period (4 – 28 June).

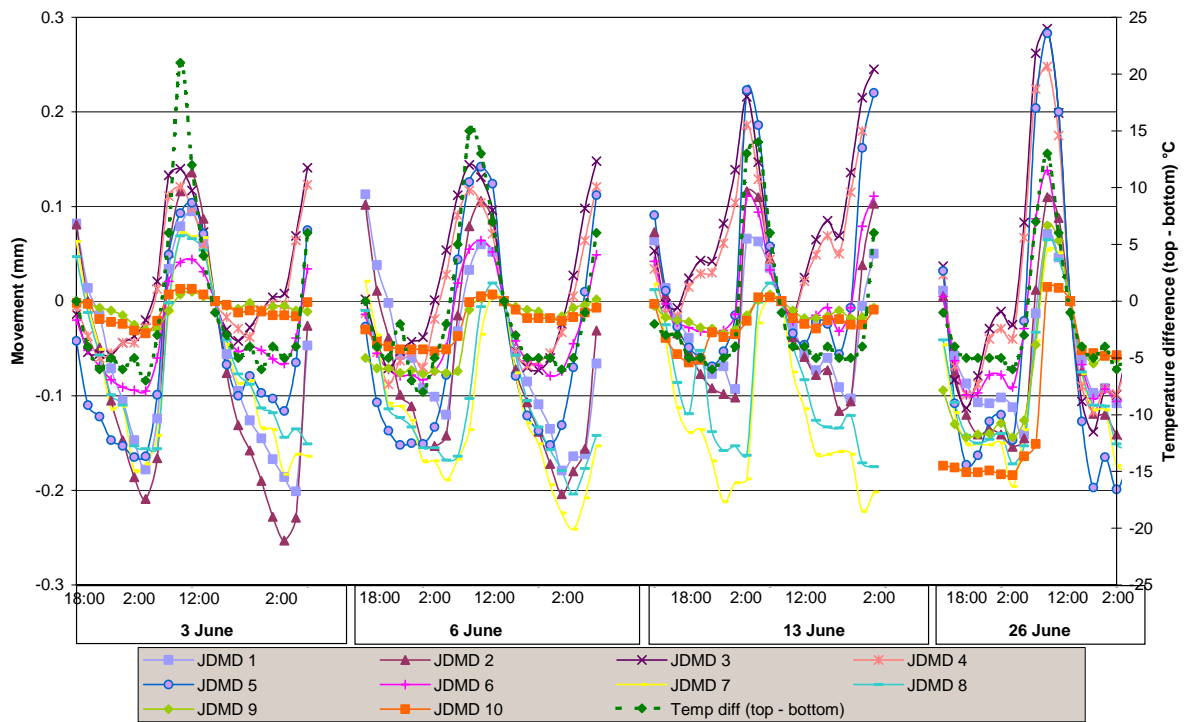
**Figure 5.13 Measurements of slab curl during HVS testing**

The data for all the JDMDs placed along the edge of the section (JDMD1 to 10) can be seen in Figure 5.13. The data are plotted in 2-hour intervals, starting at 18:00 and ending 40 hours later, at 10:00 on the next day but one.

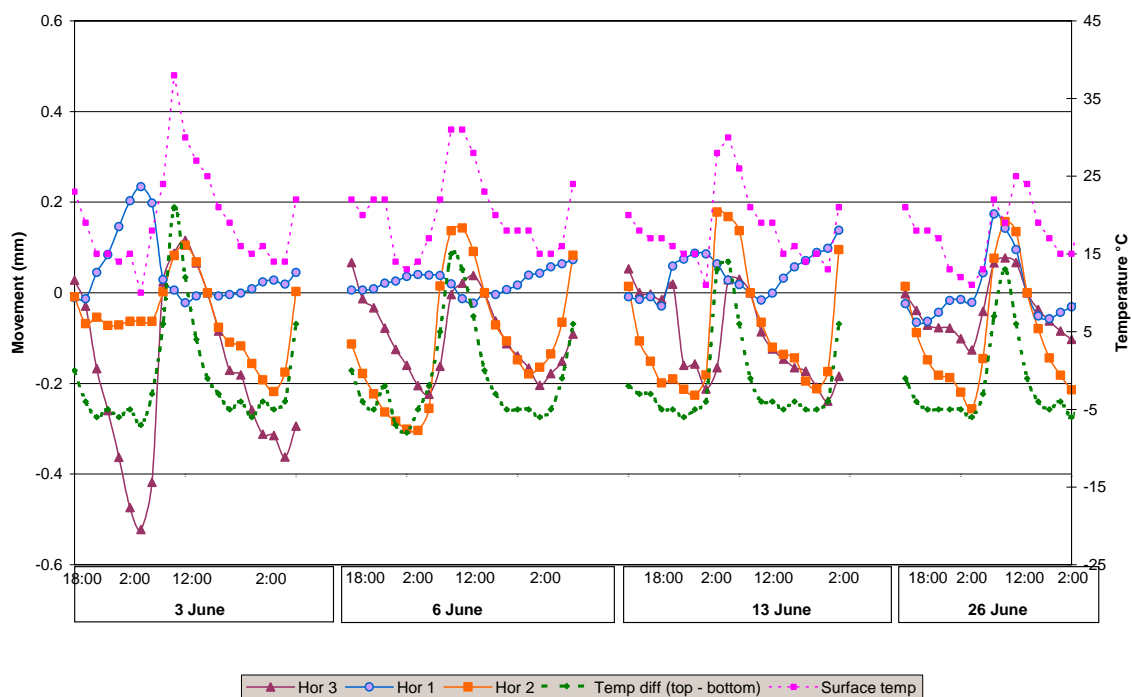
**Figure 5.14: Horizontal slab expansion / contraction due to daily temperature changes**

As discussed in Section 5.2, concrete contracts and expands under the influence of daily temperature changes. With the aid of the JDMDs placed horizontally across certain cracks it was possible to measure the horizontal movement of the slab between the cracks. To investigate this effect, the same four periods mentioned above were investigated (3, 6, 13 and 26 June 2004). The data are illustrated in Figure 5.14 and are summarized in Table 5.3. Because the expansion and contraction of the slab are mainly a function of the surface temperature (and, to a lesser extent, the temperature difference between the top and the bottom of the slab), the surface temperatures for each 40-hour cycle are also shown on the graph.

Note: Data of JDMD Hor 1 for 3rd of June is unreliable (see Fig 5.14)

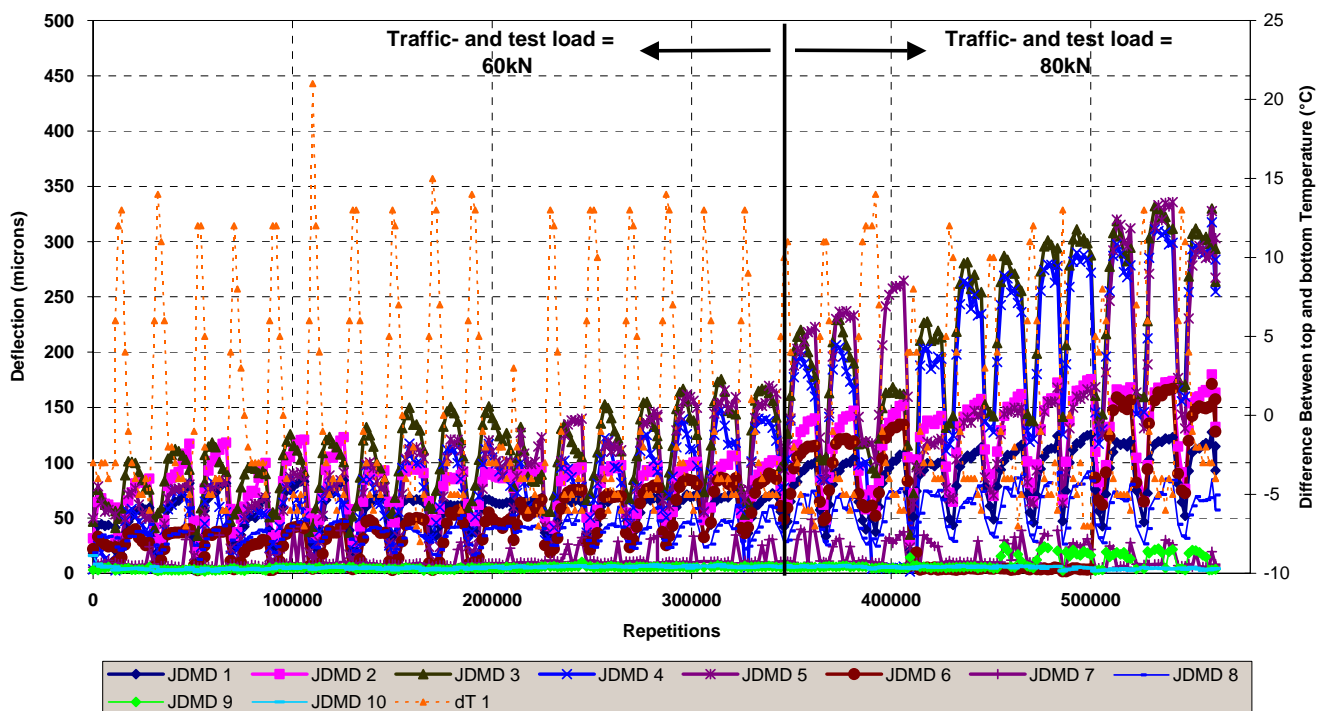
**Figure 5.15: JDMD deflections**

Figure 5.15 shows the deflections recorded by all the JDMDs placed along the edge of the slab recorded. The figure shows the deflections measured “on the fly” under the trafficking load at the time of data collection every 2 hours. The daily temperature difference (top – bottom) is also shown on the graph.

The cyclic variations recorded by the JDMDs are due to the daily temperature fluctuations. As the temperature differential increases (during the hotter part of the day) The slab curls downwards. The downward movement causes the slab to have better contact with the underlying support structure, resulting in a decrease in deflections all along the edge. At night a negative temperature differential was recorded (the slab being colder at the top than at the bottom) which resulted in the slab curling upwards. This upward movement caused the edge of the slab to become detached from the underplaying support, resulting in higher recorded deflections.

After 344 114 repetitions the trafficking and testing load were increased to 80 kN, which explains the sudden increase in deflections from that point onwards.

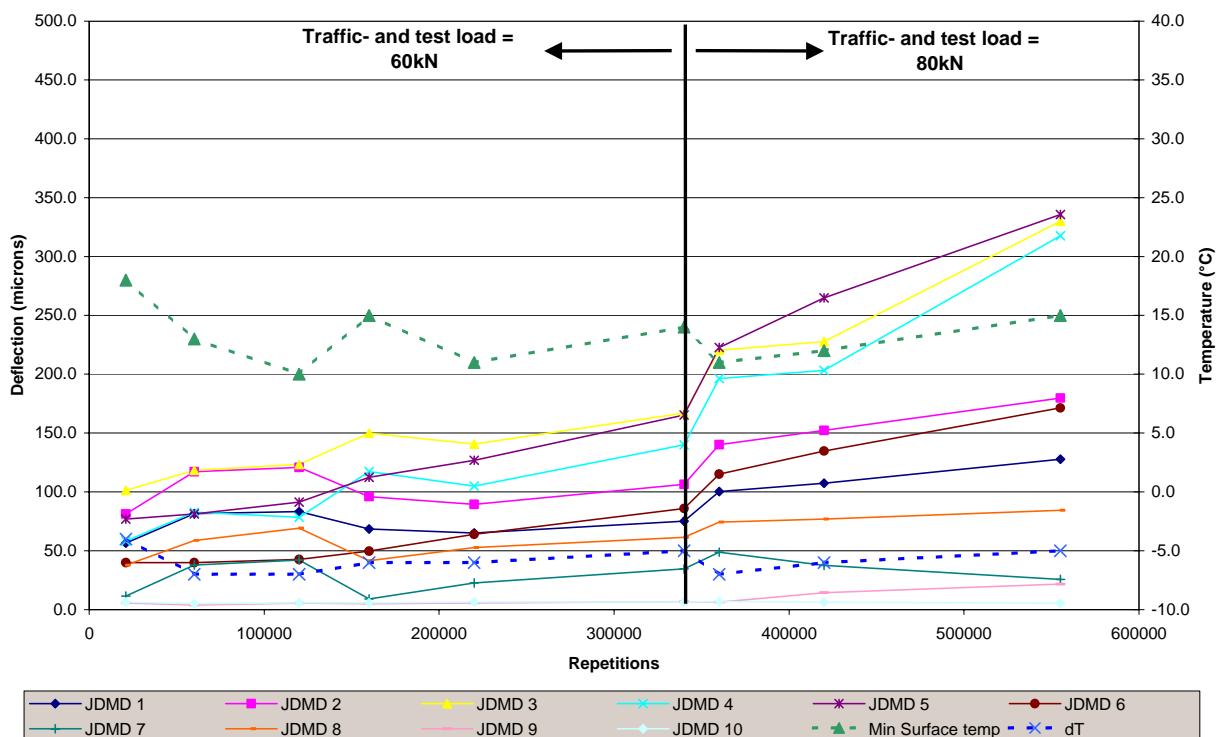
Figure 5.16: JDMD maximum deflections at night

To investigate Figure 5.15 in greater detail, the deflections during the hottest part of the day were isolated from the deflections during the coldest part of the night. Figure 5.16 shows the maximum deflection that occurred at night together with the minimum surface temperature and corresponding temperature differential (top – bottom) during nine selected periods during testing. Figure 5.17 shows the minimum deflection that occurred during the hottest part of the day. The figure also shows the maximum surface temperature together with the corresponding temperature differential (top – bottom) on the 2<sup>nd</sup> Y-axis.

The first important observation is the relationship between surface temperature, temperature differentials and deflection. During the night as the slab cools down, the temperature differentials were in the order of  $-5^{\circ}\text{C}$  (the surface temp was approximately between  $10$  and  $15^{\circ}\text{C}$  at that time) and deflections were approximately 3 times higher for the  $60\text{kN}$  case, than those recorded during the hottest part of the day when the temperature differentials were in the order of  $10$  to  $15^{\circ}\text{C}$  (with corresponding surface temp of approximately between  $25$  and  $35^{\circ}\text{C}$ ). The same conclusion is made as with Figure 5.15: During the day, the slab expands and curls downwards, which results in better contact between the slab and the underlying support layers. This higher degree of contact between the PCC slab and the base results in an decrease in deflection. At night the opposite occurs: The edge of the slab curls away from the base and this reduction in support causes an increase in deflection.

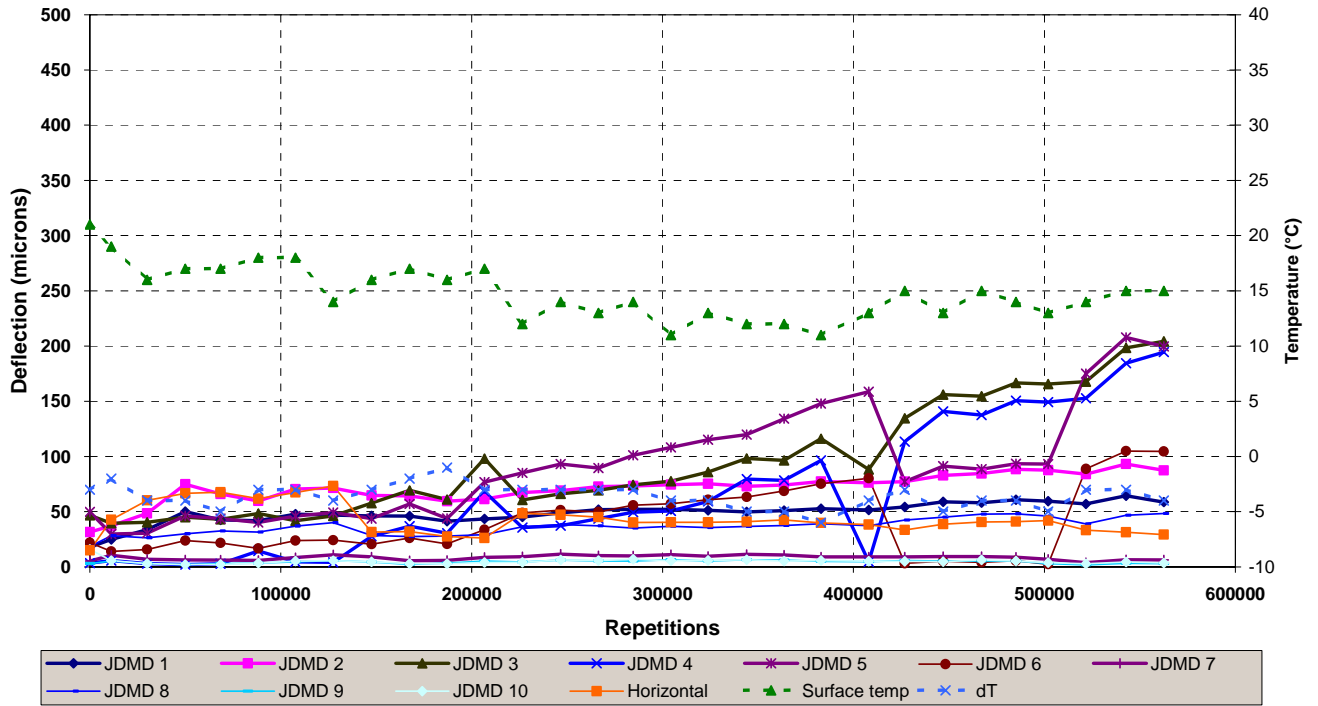
**Figure 5.18: JDMD deflections under a 40kN test load**

As can be seen from Figure 5.18 the temperature was fairly constant at about 8:00 in the morning when the data were collected and the increase in deflections is due to the damage caused by the applied loading. The irregularities in the data from JDMD 4 and 5 between about 400 000 and 500 000 repetitions are probably due to the water which was added to the cracks.

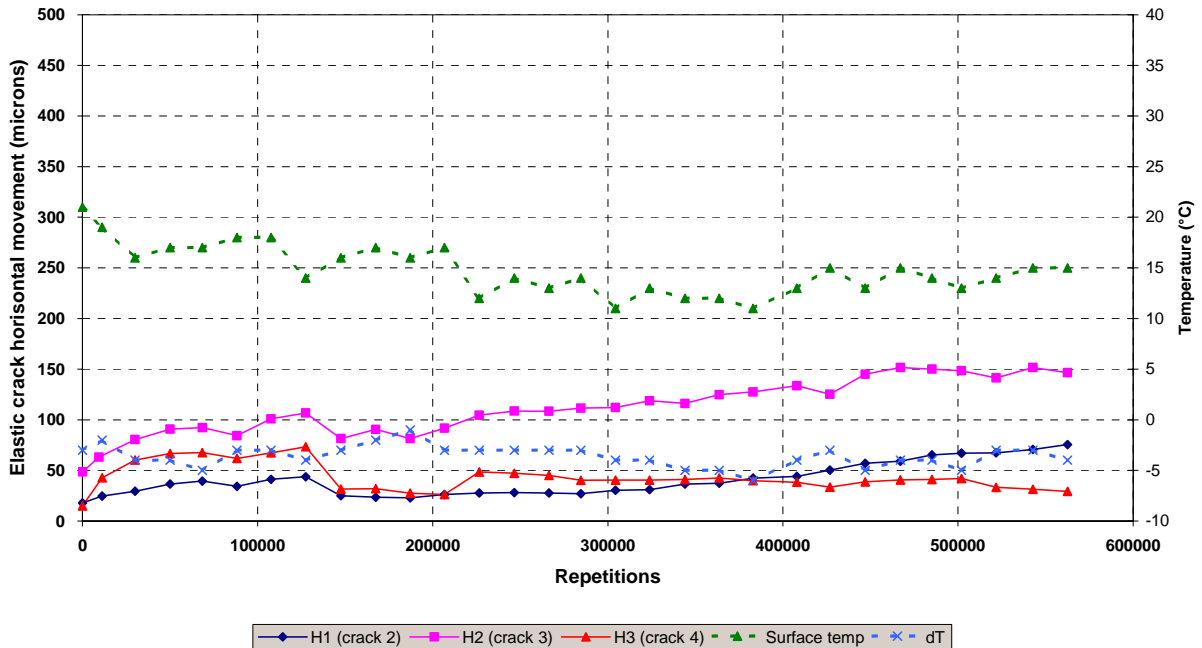
**Figure 5.19: Horizontal crack movements under 40kN loading**

It is clear that the trafficking load had very little influence on the horizontal movement of Cracks 2 and 4. The measured crack movements were less than 75 microns throughout the test. However, the movement recorded at Crack 3 increased with loading. At the

start of the test movements in the order of 50 microns were recorded, which gradually increased to about 150 microns towards the end of the test. The fact that very little or no change in horizontal movements could be detected with loading is probably due to the steel reinforcement, which kept the concrete slab intact despite the severe loading regime and existing crack pattern.

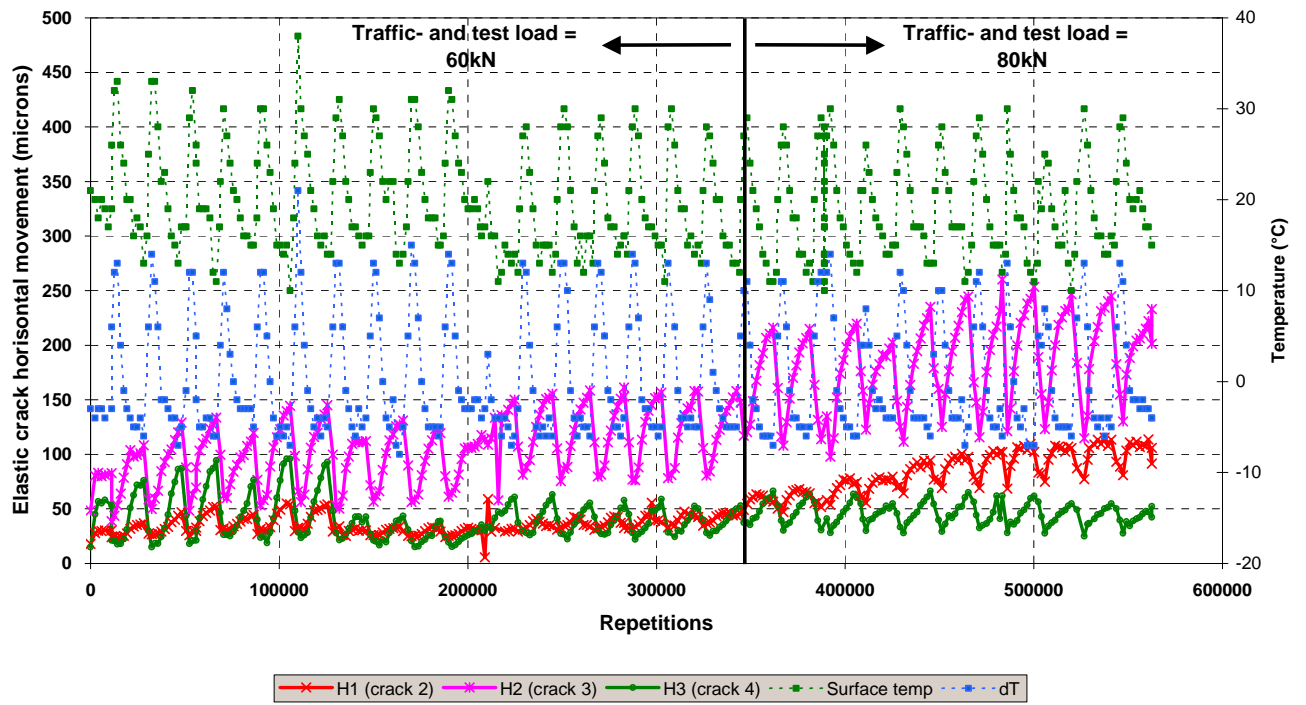
Figure 5.20: Horizontal crack movements under 60 and 80kN loading

The data for the 60 and 80kN loading cases can be seen in Figure 5.20. The same cyclic effect as that seen with the JDMDs (see Figure 5.15) is observed here. Elastic crack movements are reduced at high surface temperatures and vice versa. Crack 3 had the greatest degree of movement followed by Cracks 2 and 4. It is obvious that the high trafficking load (80kN) had an impact on the crack movement and a noticeable increase in crack movement is observed after the wheel load was increased to 80kN. This effect was more evident in the case of Crack 3 than in the others.

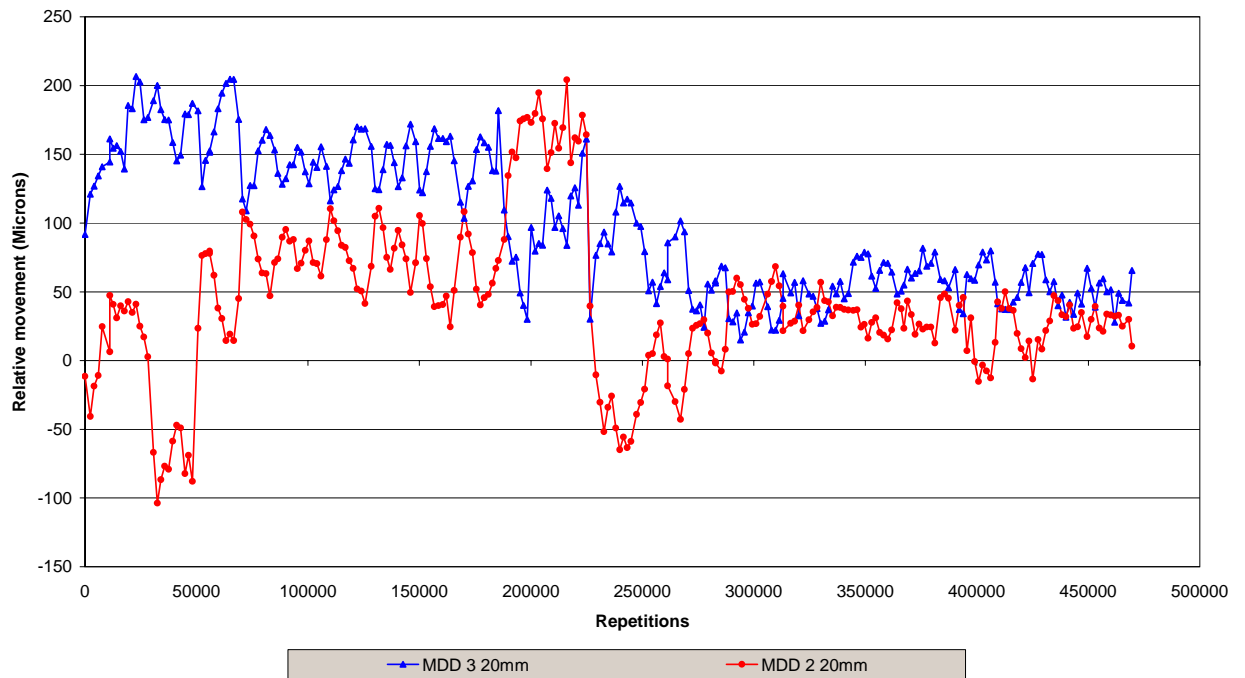
**Figure 5.26: Relative movement at Crack 3 measured by MDDs**

As explained earlier, the MDD results of the first 220 000 repetitions are suspicious and should be ignored. As seen from Figure 5.26 the relative movements in the forward and backward calculations are low (in the order of 0.05 mm) under the influence of a 40kN test load. This indicates that despite the crack and the reinforced steel together with aggregate interlock, good load transfer is taking place and even after the 80kN loading phase, no deterioration of the crack could be detected.

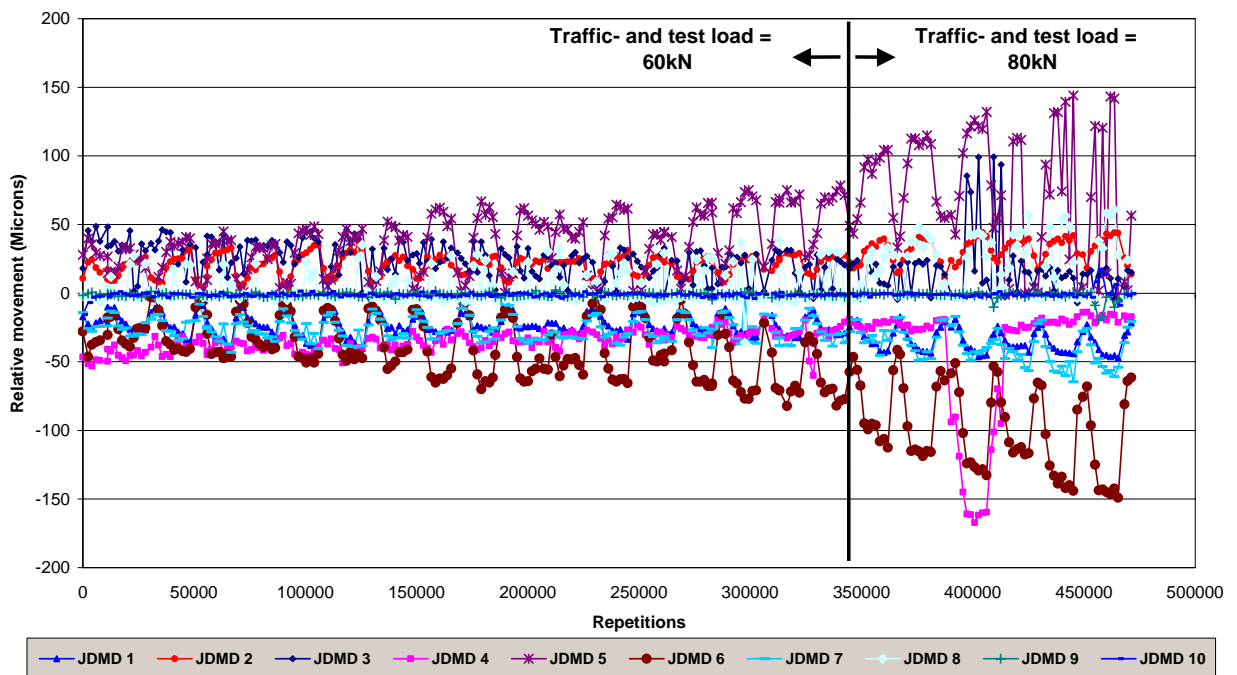
**Figure 5.27: Relative movement at all cracks measured by the JDMDs**

As seen from Figure 5.27, almost all the cracks display a very low degree of relative movement except at Crack 3. The relative movement at Crack 3 is measured by JDMD 5 (in the forward calculation) and JDMD 5 (in the backward calculation), which show a noticeable degree of deterioration after the load was increased to 80kN. Relative movements in the order of zero to 50 microns were recorded, which increased to approximately 150 microns towards the end of the test. A relative movement of 150 microns (0.015 mm) is still considered to be low, especially in light of the fact that these movements were caused by a 80kN half axle load.

The cyclic variation is due to the daily temperature variations as explained earlier. Obviously during the cold part of the night the slabs cool down and contract. This contraction causes a drop in the degree of aggregate interlock and an increase in relative movements is observed. During the day the slabs expands which causes an increase in the degree of aggregate interlock. This obviously leads to a decrease in the relative movements as displayed in Figure 5.27.
